## Inspection Report

**Property Address:**  
9774 San Cir  
Beverly Hills CA 90210

**Inspection Industries, LLC**

<b>Date:</b> 6/28/2023	<b>Time:</b> 10:00 AM	<b>Report ID:</b> 9774San
<b>Property:</b> 9774 San Cir Beverly Hills CA 90210	<b>Customer:</b> REvesty LLC	<b>Real Estate Professional:</b>

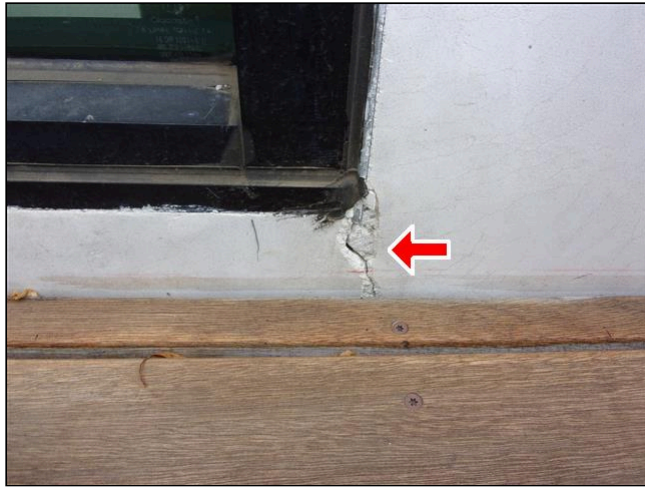
- 1** The exterior siding is cracked at the rear under a living room window and at the left, under the primary bathroom. Have a qualified licensed contractor repair to prevent water intrusion as needed.

Cracked Siding, Rear Living Room Wall

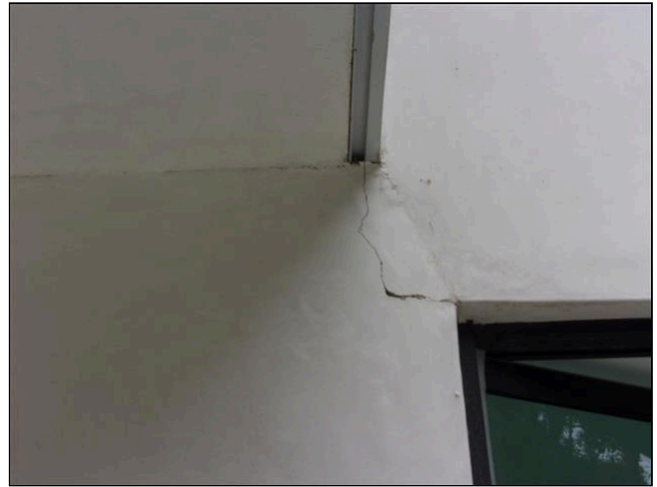
Cracked Siding, Left Side

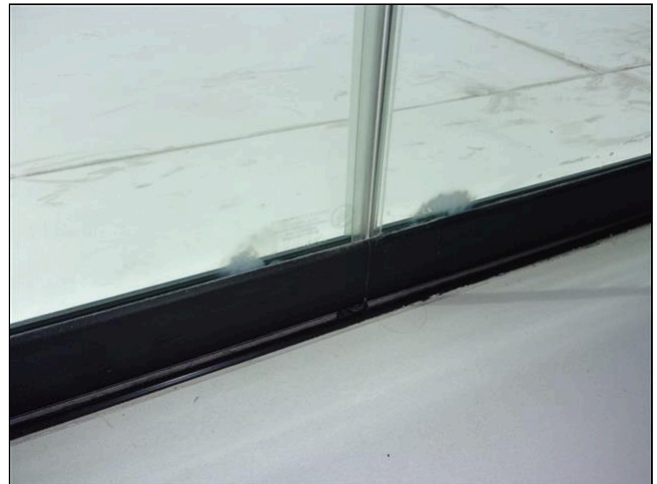
- 2 The sliding glass doors throughout the home are generally difficult to move, many panes have missing or damaged weather stripping, several base tracks are holding water, seals between glass & frame appear to have gaps that may allow water intrusion, tint in the glass appears to be damaged or discolored and one glass pane is chipped and damaged at the left side of the living room. Active leaking is suspected during rains as discolored and damaged ceilings were observed in the living room, kitchen and garage. Have a qualified licensed contractor or manufacturer's representative evaluate further and perform all necessary repairs or replacement throughout the home.

Damaged Tint

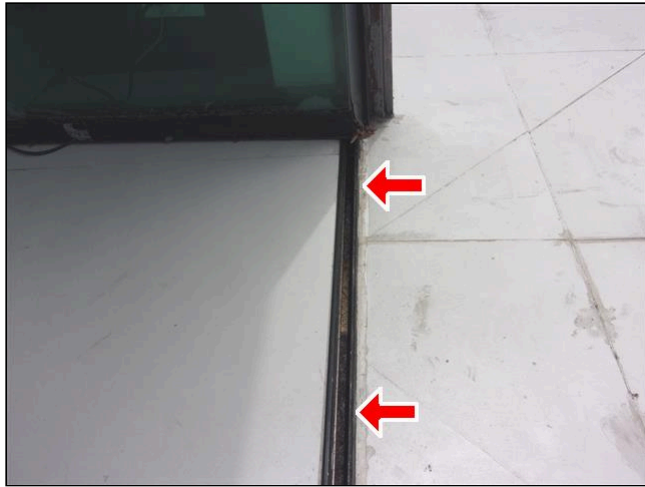
Water In Base Tracks

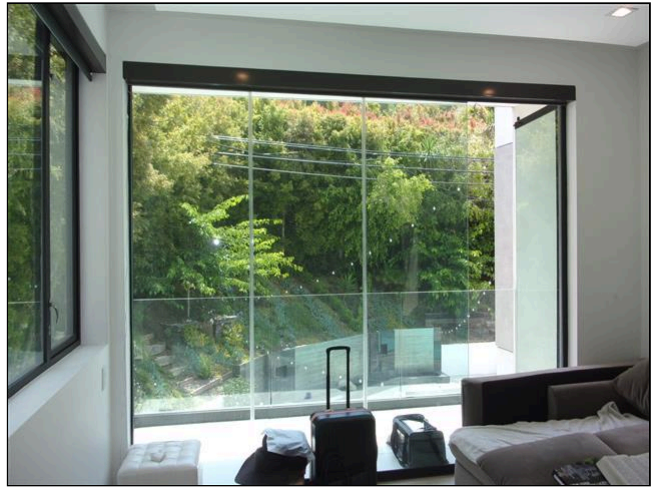
Doors Difficult To Slide

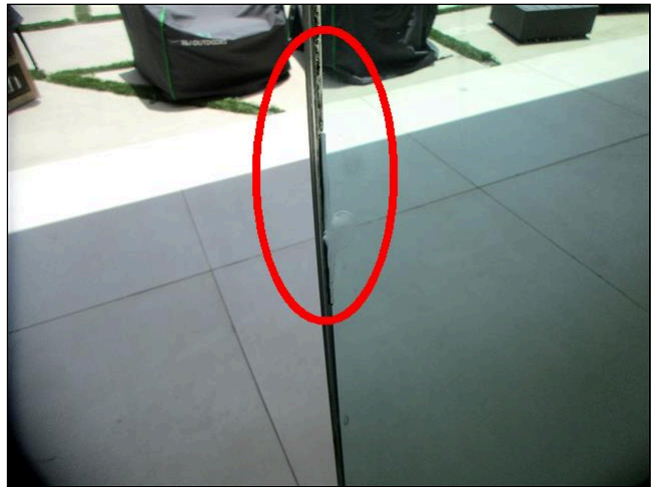
Chipped, Damaged Glass

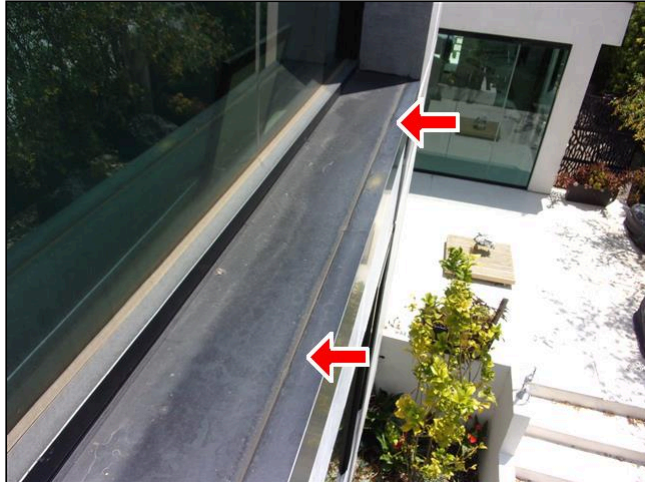
- 4 Window flashing at the right rear guest bedroom fixed window pane has been installed with a slope toward the home/window. This will trap water against the home and may allow water intrusion during

rains. Have a qualified licensed contractor evaluate further and repair/replace the flashing to divert water away from the home, as needed.

Flashing Incorrectly Sloped

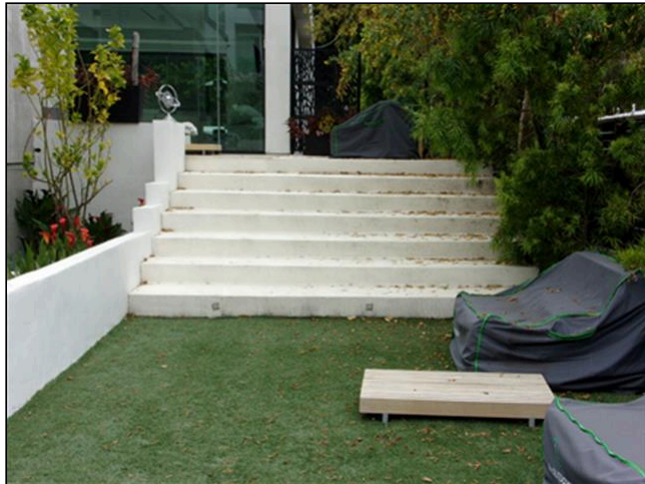
- 5 The exterior stairs to the 1st level game room and at the rear patio are missing hand railing. Typically steps of 3 or 4 more require a graspable railing as a fall or injury could occur. A hand rail should be installed for safety by a qualified licensed contractor.

Railing Missing, Rear Steps

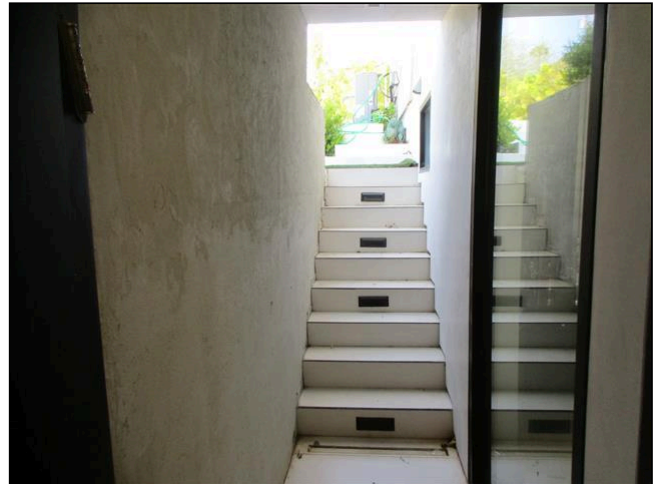
Railing Missing, Right Side Steps

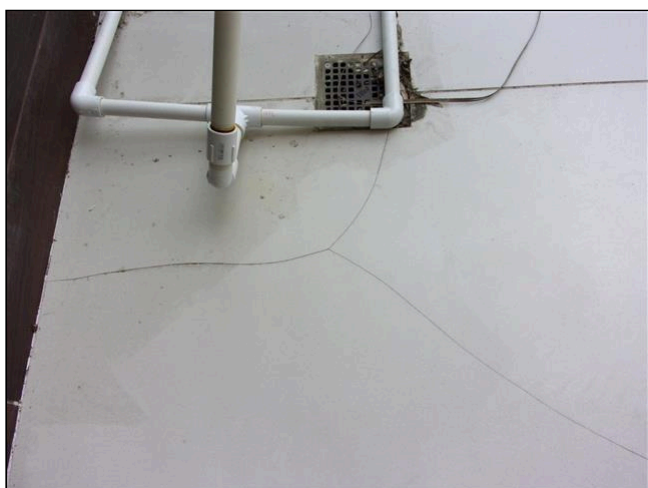
- 7 The tile balcony surface is cracked, outside the top level loft. This may allow water intrusion and hidden damage to occur. A qualified licensed contractor should repair as needed.

Cracked Tile Surface

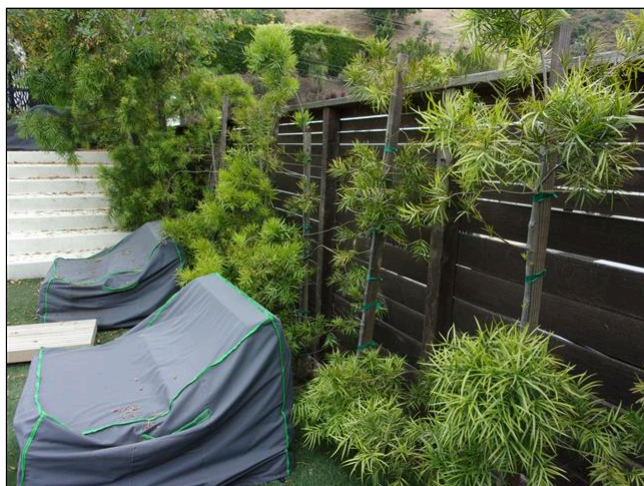
- 8 Fencing at the rear is incomplete behind the pool area and the existing wood fencing at the rear is leaning. A qualified licensed contractor should repair for safety, as needed.

Leaning Fencing

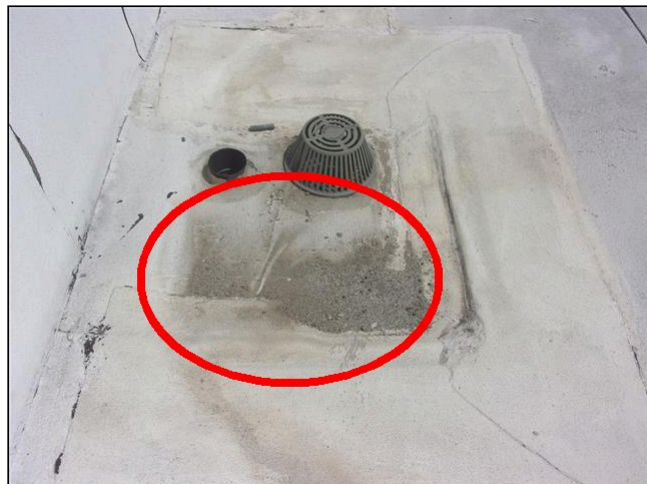
- 9 The roof covering is cracked at the front right area and the scupper collection area is weak as hidden damage may exist at the right side of the roof. Have a qualified licensed roofing contractor evaluate further and perform all necessary repairs.

Weak Spot, Right Side Scupper

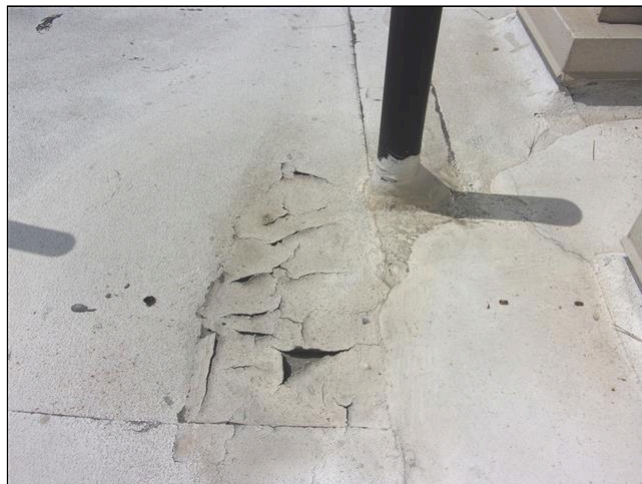
Cracked Roof Covering

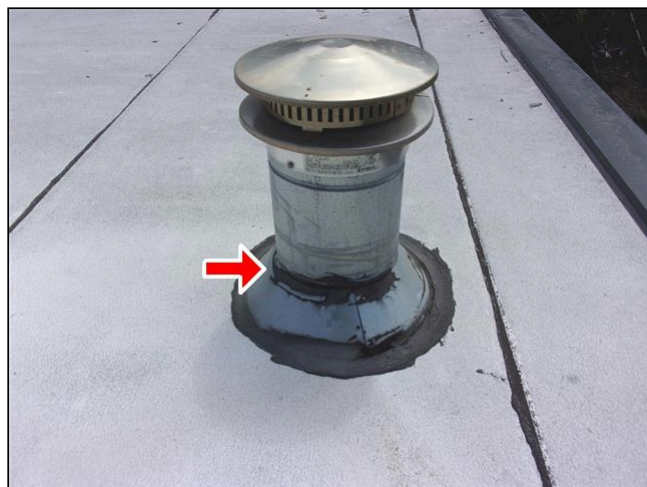
- 10 Gaps exist at the primary bedroom chimney vent stack roof flashing. This may allow rain water into the home causing damage. Have a qualified licensed roofing contractor properly seal the flashing to prevent potential leaking.

Gaps In Flashing

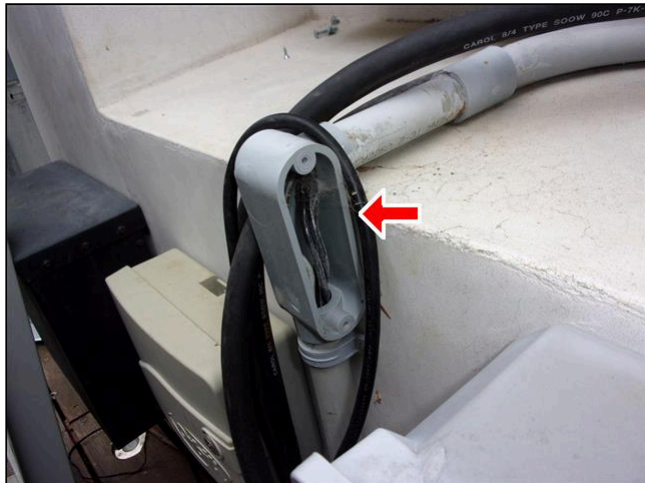
- 14** An open "L" electrical box exists at the rear exterior, under the main electrical panel. Have a qualified licensed electrician install a cover for safety.

Cover Plate Missing

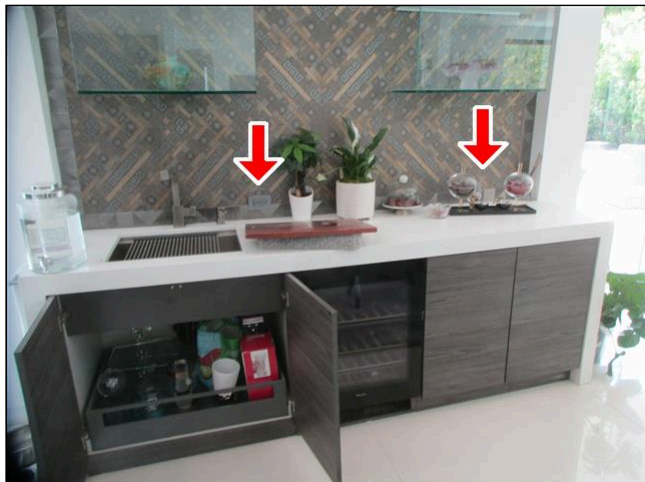
Outlets Not Operational, Kitchen

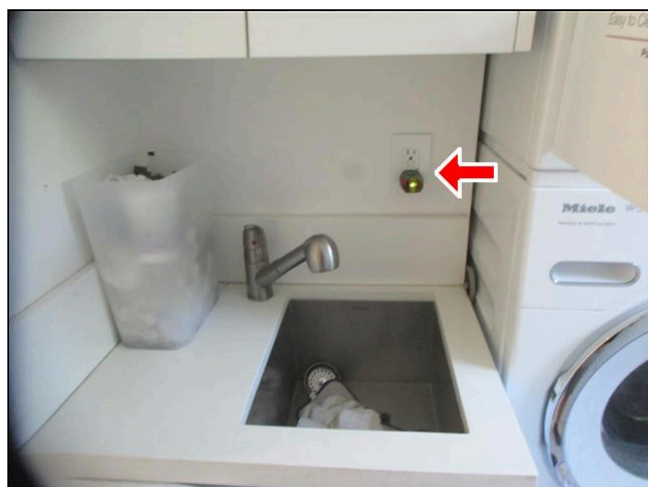
- 18** An electrical outlet tests with an open ground at the laundry room sink. This incorrect installation and is a safety issue that needs to be corrected by a qualified licensed electrical contractor.

Ungrounded Outlet

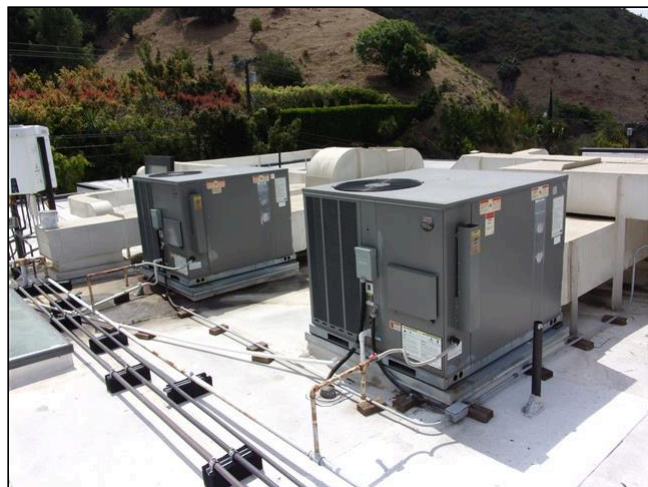
- 19** **NOTE:** All (4) HVAC systems were not able to be tested or operated as the thermostats were locked and the homeowner at the time of inspection insisted the systems were operational and refused to unlock for inspection purposes. The operability and conditions of the HVAC system are not known and not represented in this report. This is for your information.

HVAC Systems Not Tested

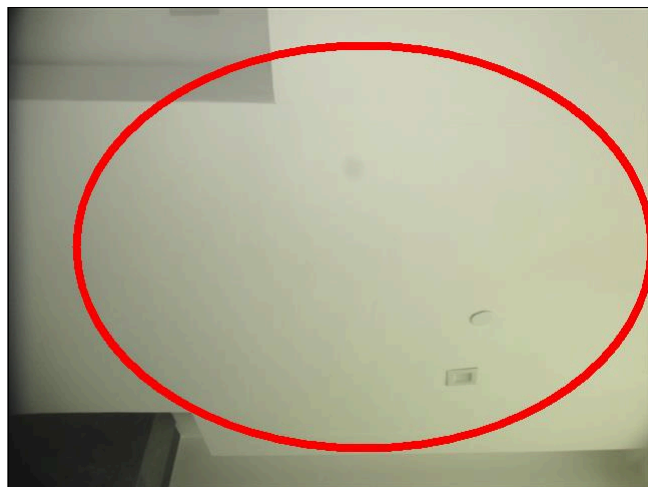
- 22 Ceilings reveal staining and damage in the living room, kitchen and garage. Leaking from the balconies/balcony doors and/or plumbing is suspected. Have a qualified licensed contractor evaluate further and perform all necessary repairs.

Stained, Damaged Ceiling, Living Room

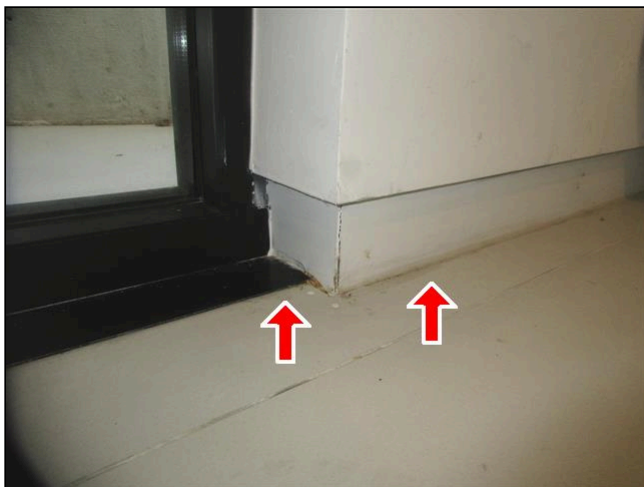
**23** The front and right walls in the game room on the 1st level are stained at the floor from water intrusion. Leaking from the adjacent exterior staircase and landing is suspected. Have a qualified licensed contractor evaluate further and perform all necessary repairs.

Signs Of Water Intrusion

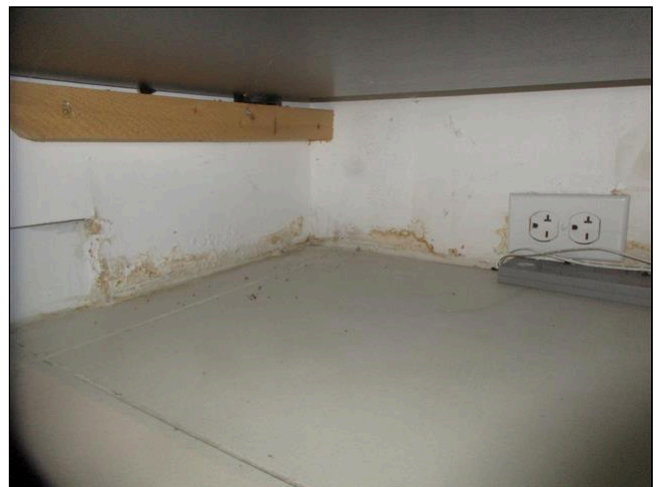
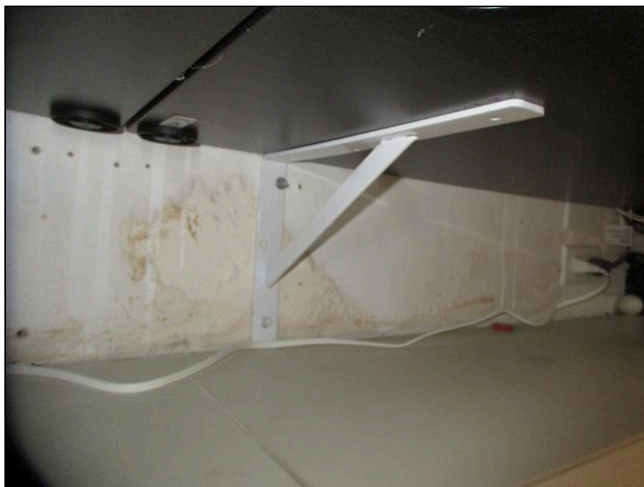
Signs Of Water Intrusion

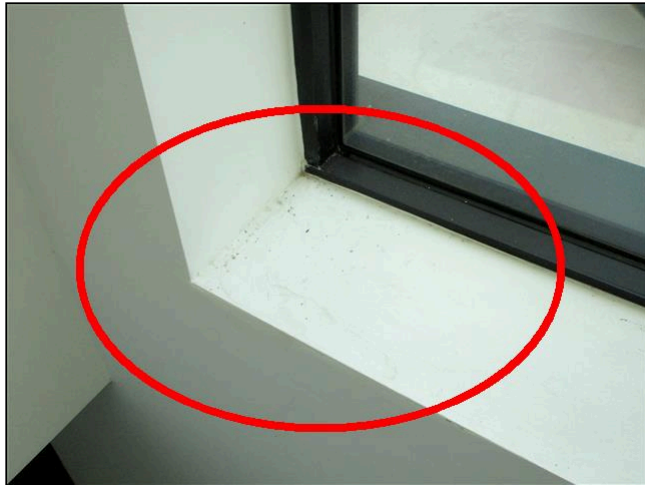
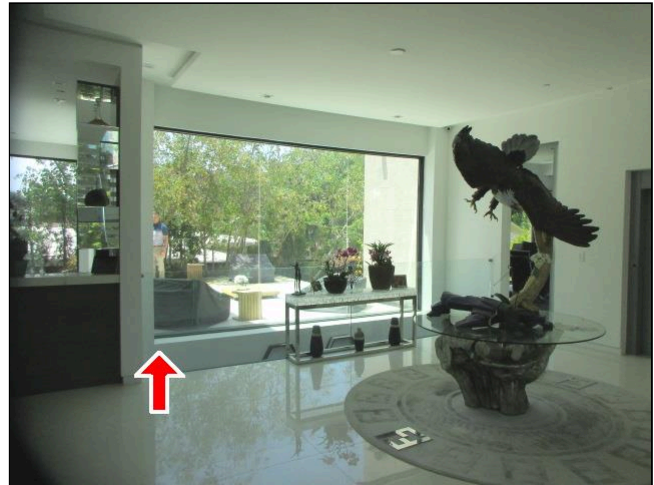
- 26 A window shows evidence of leaking at the jamb/sill at the rear wall of the main level entry. Water intrusion may continue to occur without correction. Have a qualified licensed window contractor repair as needed.

Signs Of Water Intrusion

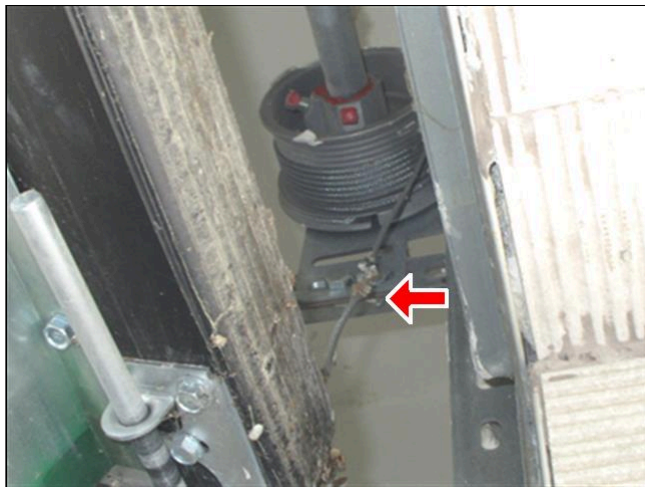
- 27 The garage vehicle door is not balanced. Tension is lost at the cables when the door is opened. This presents a safety hazard. Although the door opener was operational at the time of inspection, I recommend a qualified licensed garage door service company adjust/repair as necessary.

Loose Cables

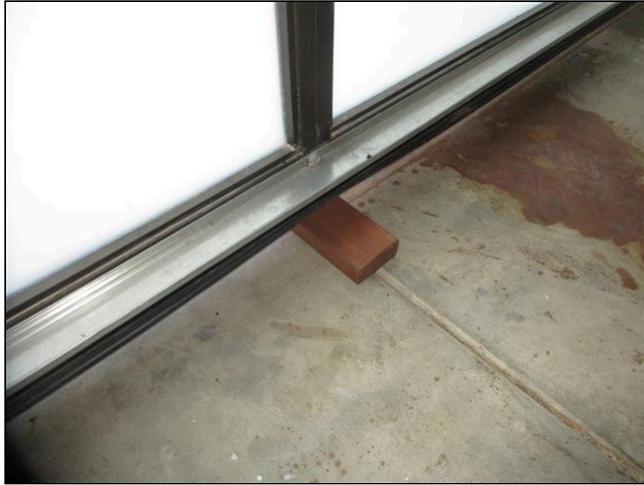
- 28 The automatic opener for the garage vehicle door will not reverse when met with resistance. This is considered unsafe and needs correcting by a qualified licensed garage door contractor.

Door Does Not Reverse

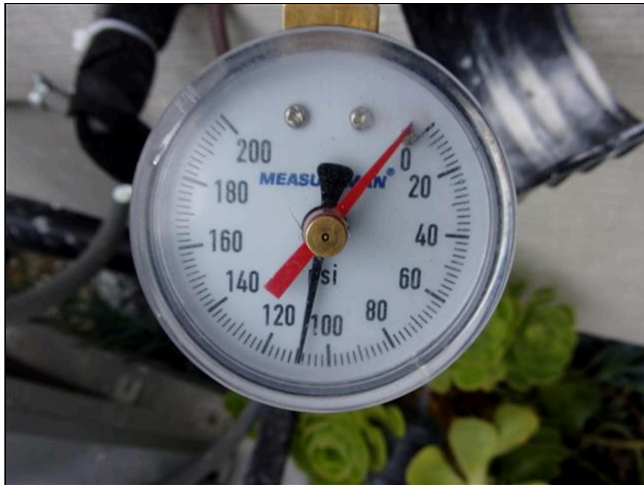
- 29** The static cold water pressure measured approximately 110psi at the exterior hose bibbs. Pressure above 80psi can cause leaking in the piping and fixtures of the home. Have a qualified licensed plumber adjust the pressure at the existing regulator valve accordingly.

High Pressure

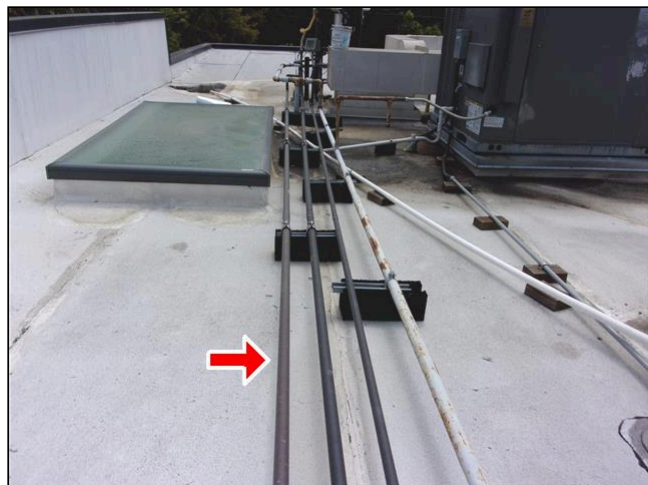
- 30** Water supply piping installed at the roof top has not been insulated. This piping is exposed to extreme temperatures which may cause fluctuations in the plumbing system. Today's standards typically required exposed piping be insulated. Have a qualified licensed plumber repair as needed.

Piping Not Insulated

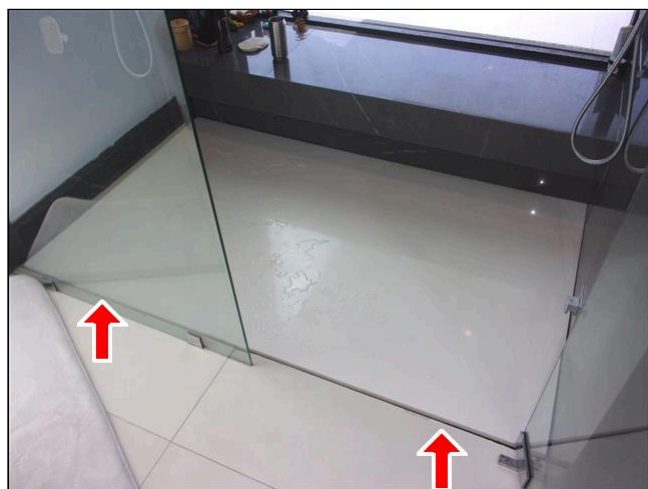
- 31 The entire shower pan floor is loose in the primary bathroom. This is incorrect installation and may allow leaking during operation of the shower. A qualified licensed contractor should evaluate further and perform all necessary repairs before continued use.

Loose Shower Pan

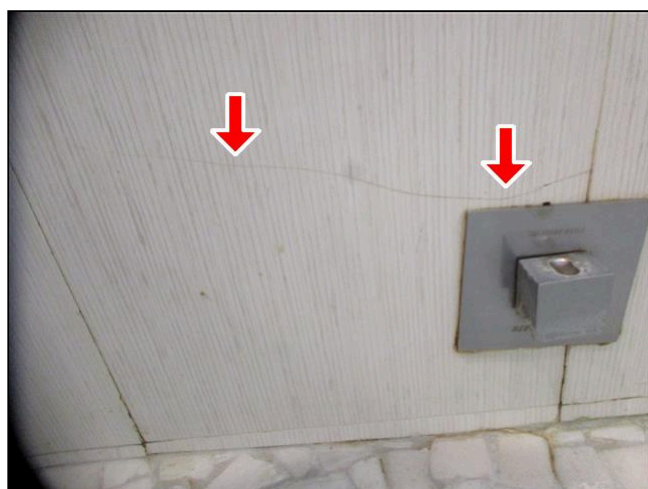
- 32 A cracked tile and loose drain cover were observed in the 1st level gym shower stall. A shower pan test should be performed by a qualified licensed contractor to determine if any leaking exists and to perform all necessary repairs.

Cracked Tile

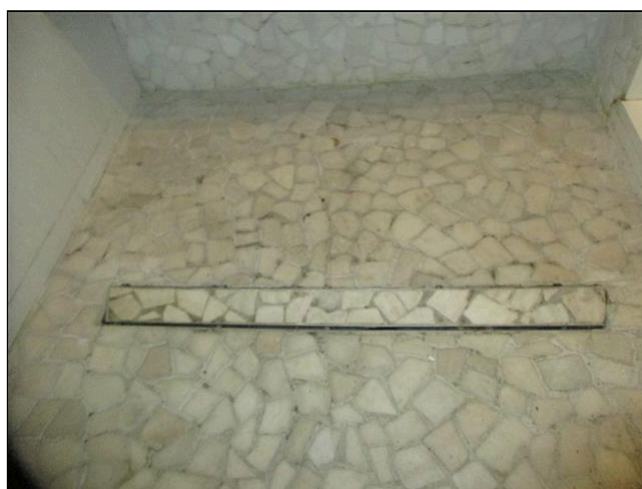
Loose Drain Cover

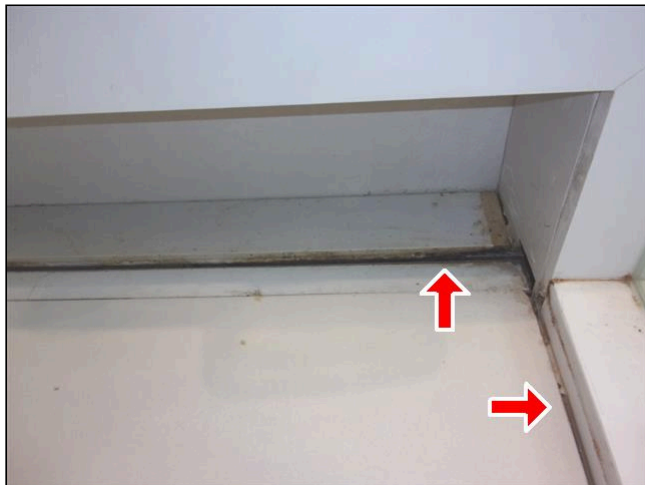
- 33** Suspected mold/fungus/mildew-like staining or substances were observed in the shower tile grout at the front left, front right and left side game room baths and on the garage ceiling. Analysis and testing for molds/fungus/mildew substances is not part of this general home inspection. I recommend evaluation and remediation by a qualified licensed contractor/hygienist/specialist in this field, as needed.

Suspected Mold/Fungus/Mildew, Front Left Guest Bath

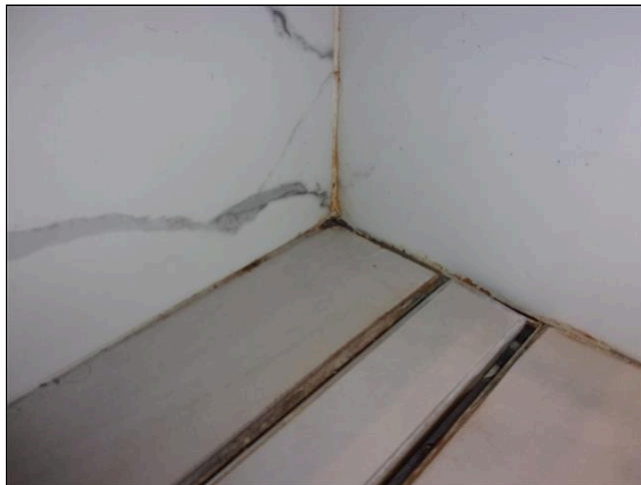
Suspected Mold/Fungus/Mildew, Front Right Bath

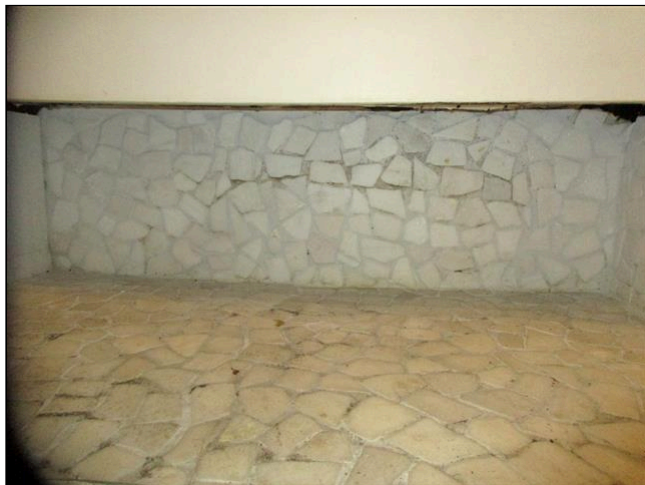
Suspected Mold/Fungus/Mildew, Left Game Room Bath

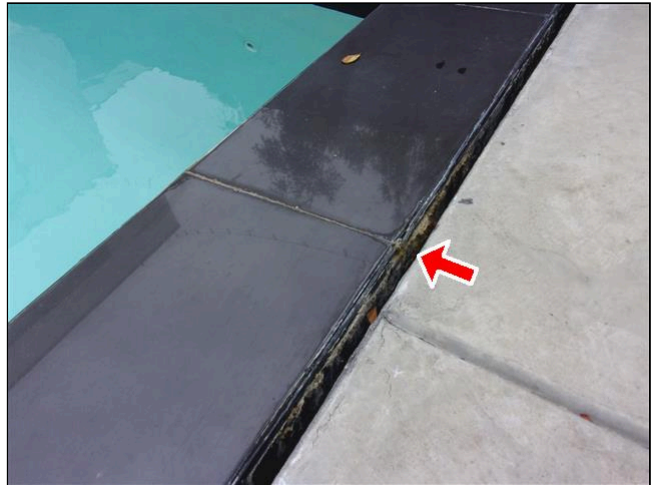
- 34** Tiles are loose around the pool & spa and the edges of the tiles are sharp at the top step of the spa. Loose tiles may allow leaking into surrounding materials and the sharp edges of the top step may cause injury. Have a qualified licensed pool contractor perform repairs as needed.

Loose Tiles

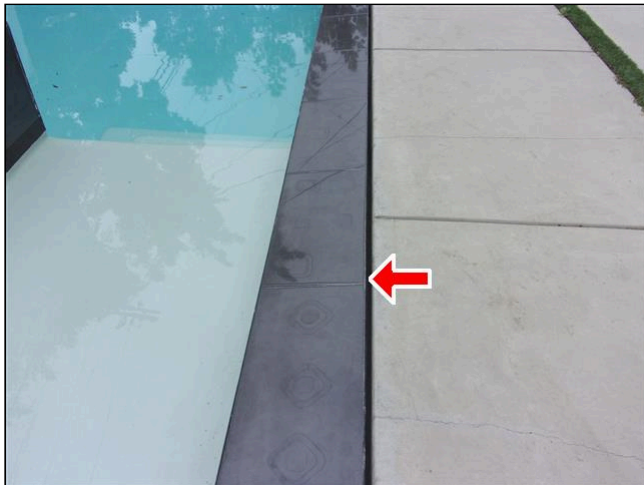
Loose Tiles

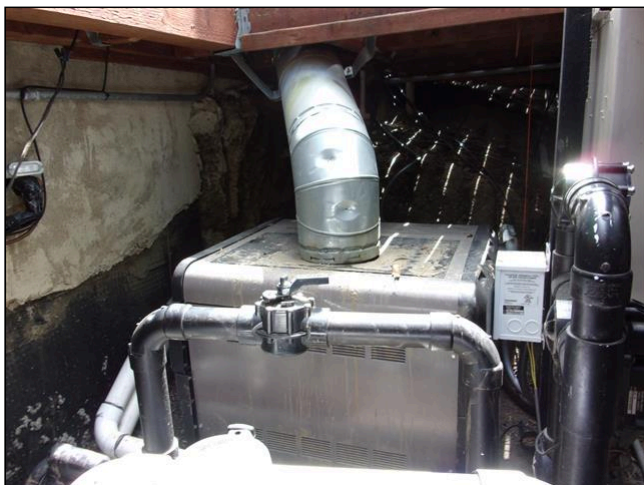
35 The pool/spa gas-fired heater failed to operate and the soil around the cabinet is too high. Have a qualified licensed pool contractor service and repair and clear away the soil for proper operation.

Heater Not Operational

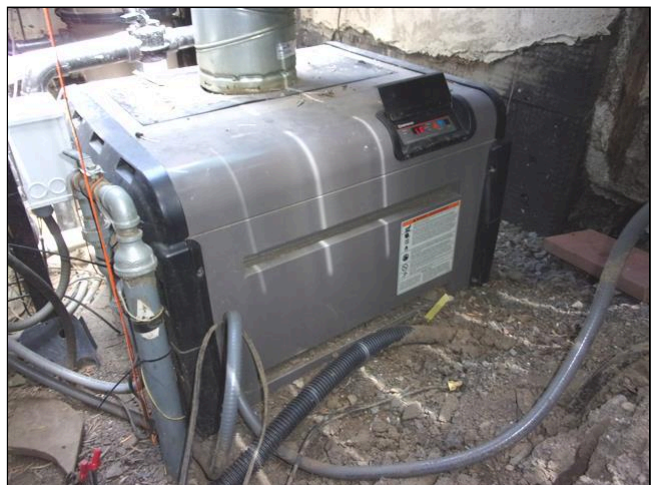
Soil Too High

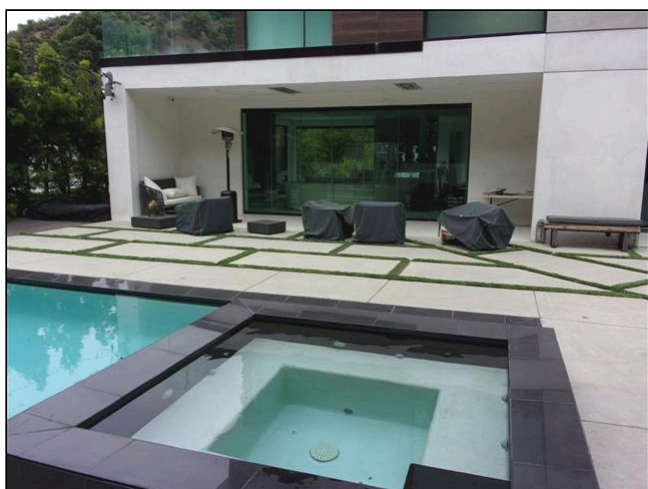
- 38 The exterior doors allow direct access from the house to the pool/spa area. This is a significant safety and childproofing issue. I recommend you have a qualified licensed pool contractor properly install an enclosure, fencing, cover, door alarms, water surface alarm and/or childproof locks as necessary.

Direct Access To Pool/Spa Area

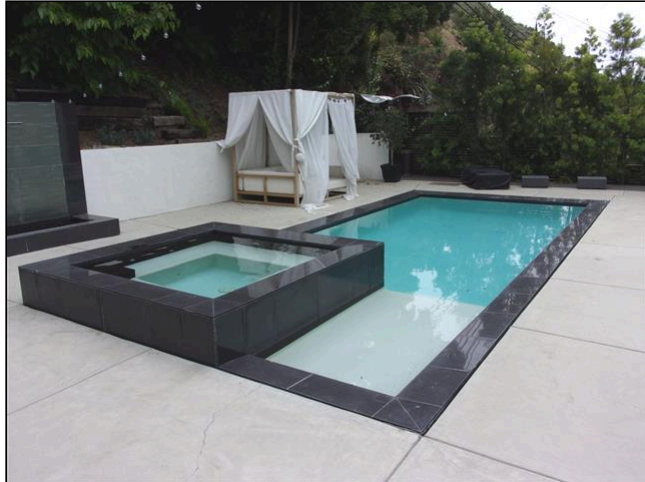
- 39 There are fewer than 2 drowning prevention safety features present regarding access to the pool/spa. At least 2 of the following safety features are now required to meet today's standards: a proper

barrier/enclosure, self closing self latching exterior doors, pool/spa safety cover, door exit alarms or water surface alarm are safety features. Contact a qualified licensed pool contractor for options, costs and installation for safety.

Less Than 2 Drowning Prevention Features Present

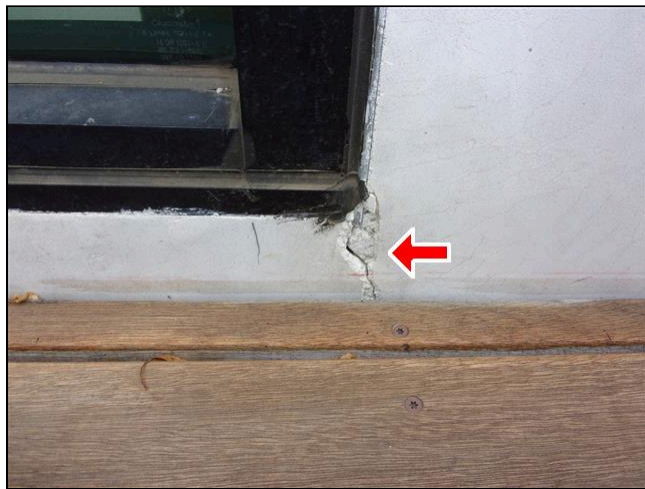
The exterior siding is cracked at the rear under a living room window and at the left, under the primary bathroom. Have a qualified licensed contractor repair to prevent water intrusion as needed.

Cracked Siding, Rear Living Room Wall

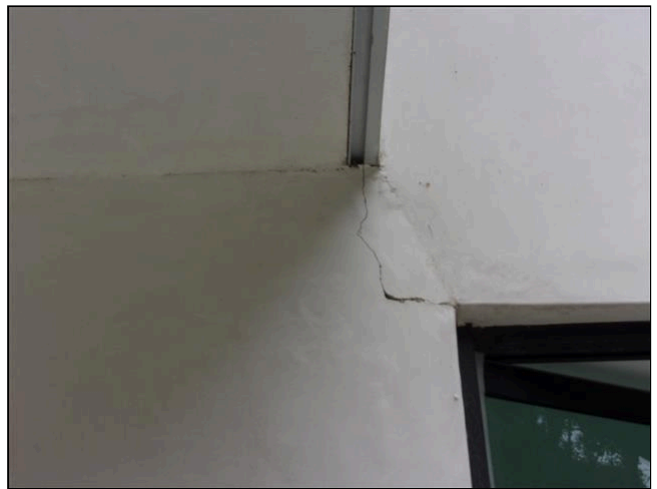
Cracked Siding, Left Side

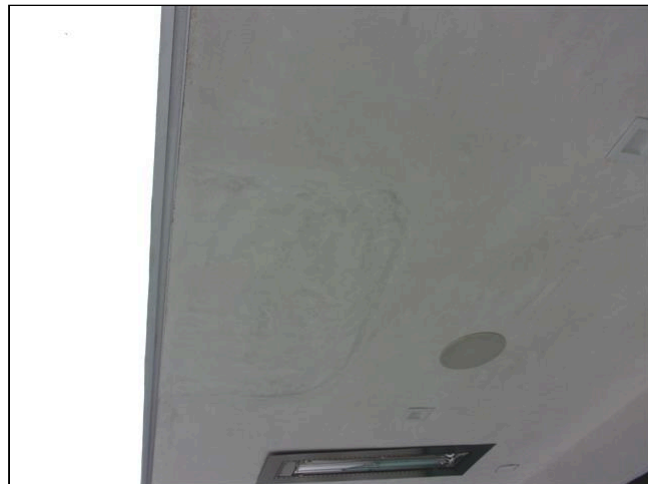
Evidence of previous repairs/ patching is present at the exterior siding at the underside of the primary bedroom balcony facing the pool. Inquire of the seller for past problems, work performed and receipts.

Repair To Exterior

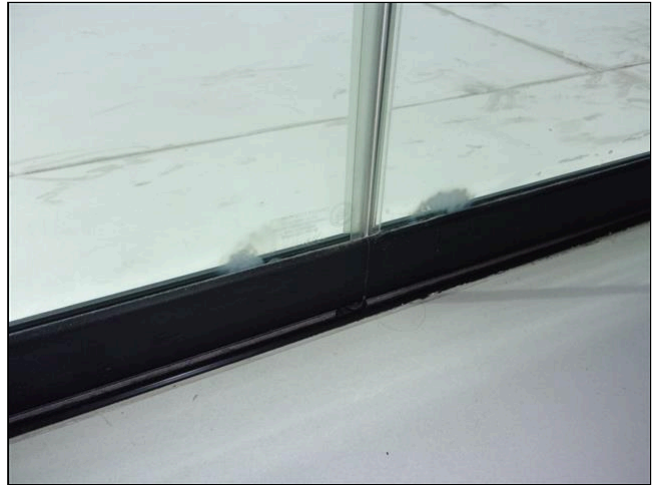
Damaged Tint

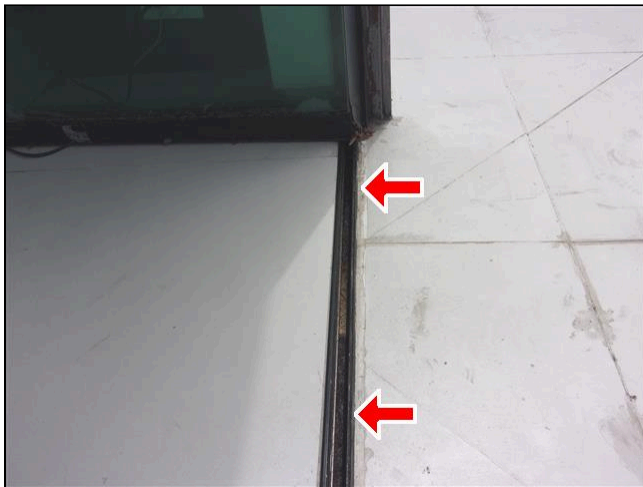
Water In Base Tracks

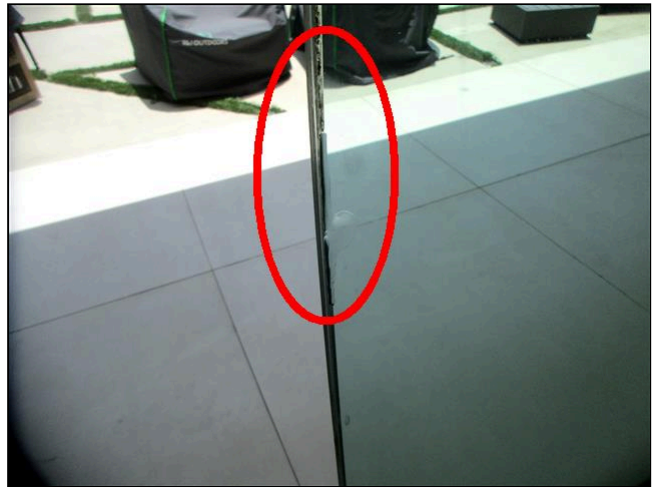
Chipped, Damaged Glass

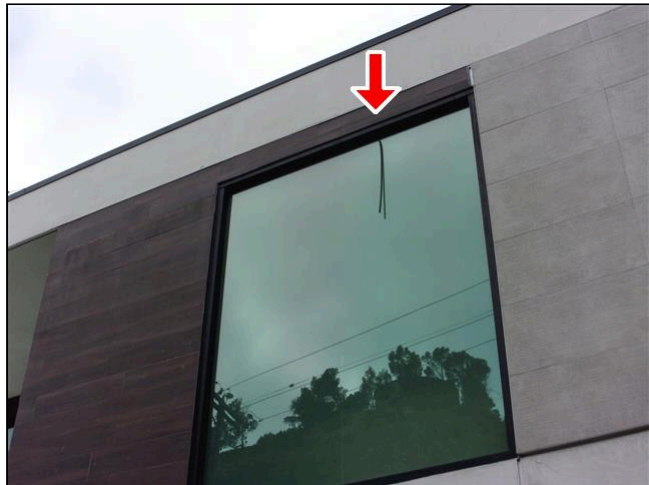
Weather stripping was observed to be loose and damaged at the primary bathroom fixed pane window, at the left side of the home. Water intrusion may occur without correction. Have a qualified licensed window contractor repair as needed.

Loose Weather Stripping

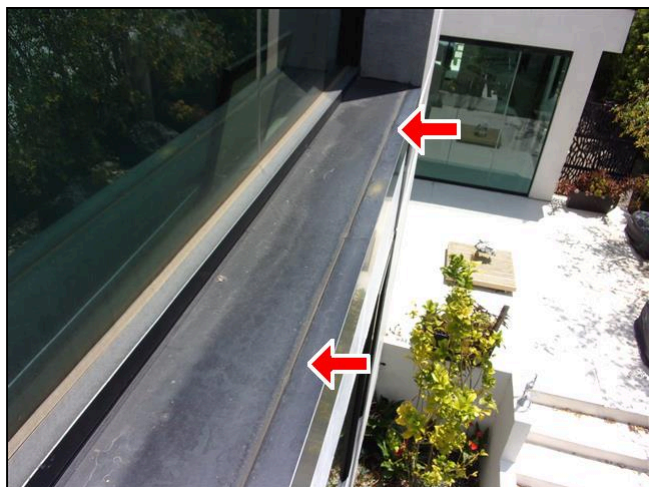
Window flashing at the right rear guest bedroom fixed window pane has been installed with a slope toward the home/window. This will trap water against the home and may allow water intrusion during rains. Have a qualified licensed contractor evaluate further and repair/replace the flashing to divert water away from the home, as needed.

Flashing Incorrectly Sloped

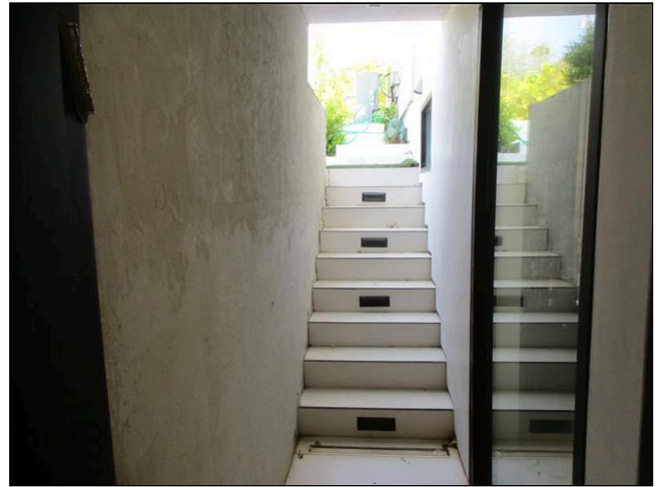
Railing Missing, Right Side Steps

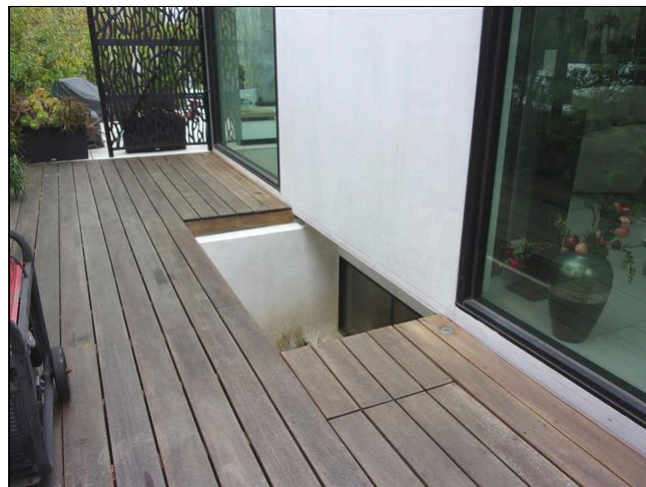
A guard rail is missing at an opening in the rear wood deck surface where a fall and injury could occur if not installed. A guard rail should be installed for safety by a qualified licensed contractor.

Guard Rail Missing

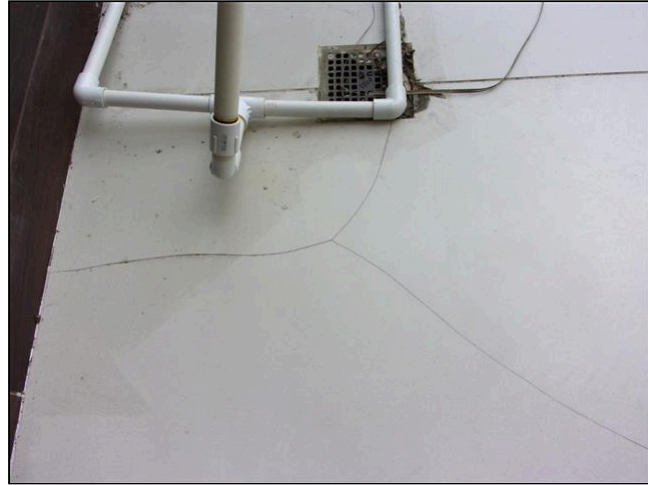
The tile balcony surface is cracked, outside the top level loft. This may allow water intrusion and hidden damage to occur. A qualified licensed contractor should repair as needed.

Cracked Tile Surface

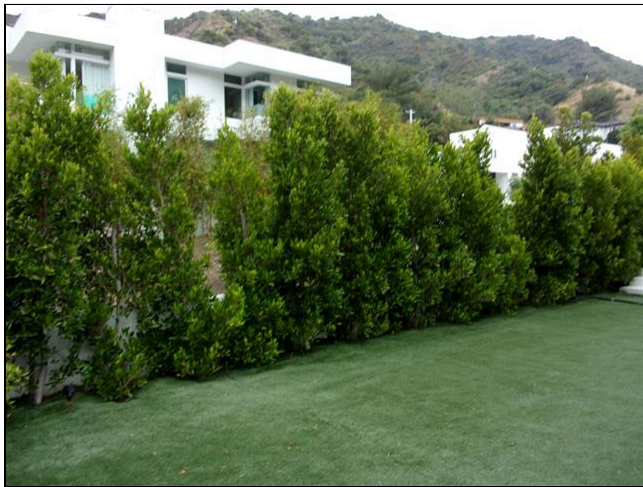
Fencing at the rear is incomplete behind the pool area and the existing wood fencing at the rear is leaning. A qualified licensed contractor should repair for safety, as needed.

Incomplete Fencing

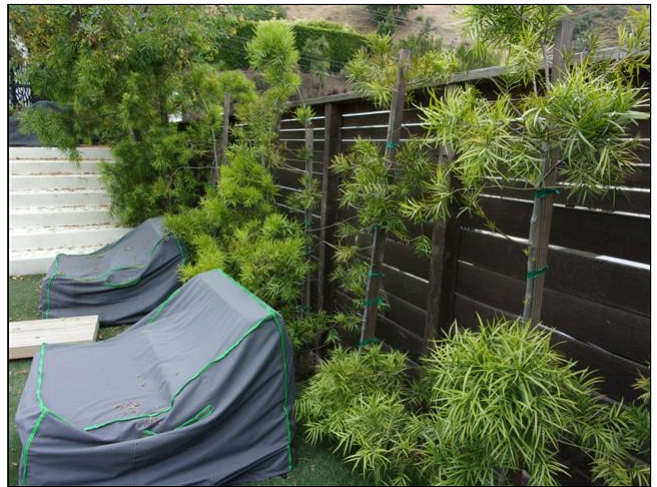
Leaning Fencing

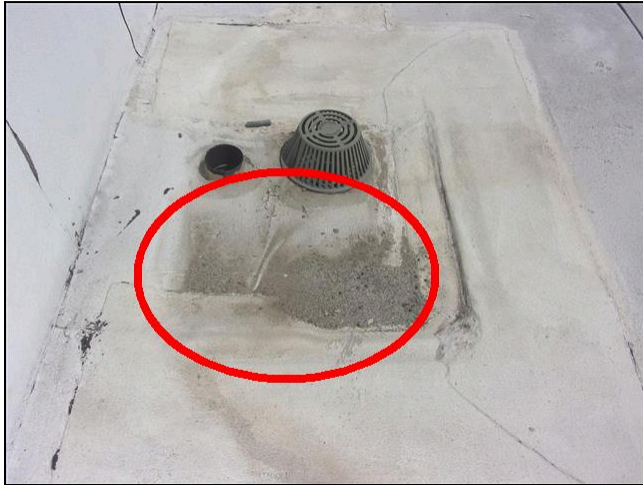
The roof covering is cracked at the front right area and the scupper collection area is weak as hidden damage may exist at the right side of the roof. Have a qualified licensed roofing contractor evaluate further and perform all necessary repairs.

Weak Spot, Right Side Scupper

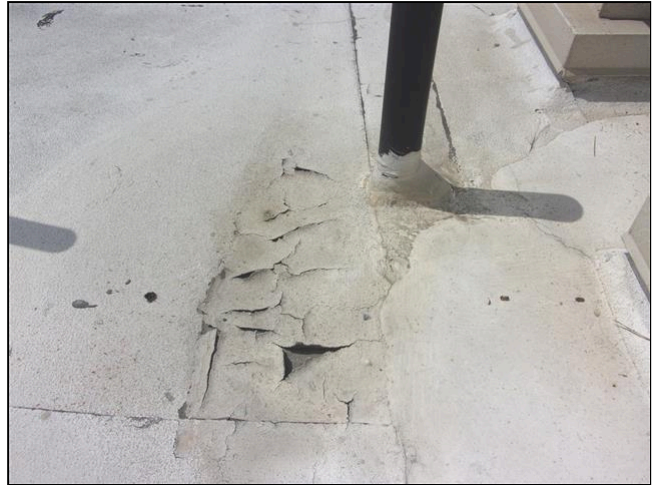
Cracked Roof Covering

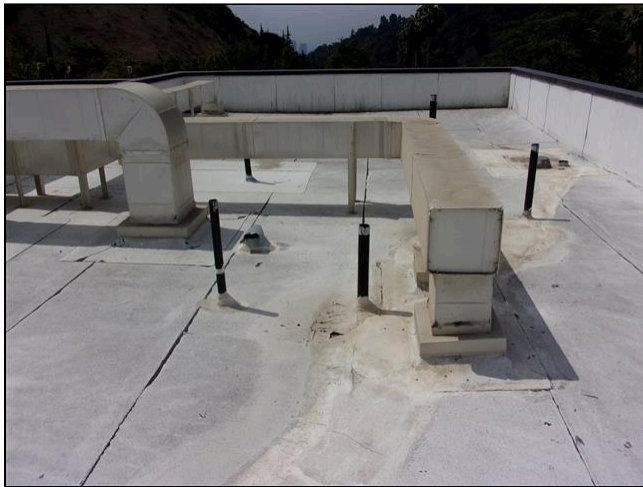
Evidence of past repairs to the roofing and exposed ducting were visible. Inquire with the seller for past problems, repairs performed and if a warranty/guarantee is transferrable. This is for your information.

Repairs

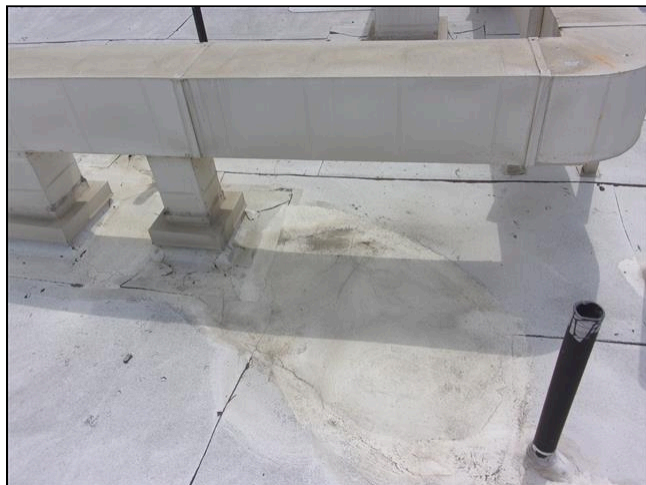
Repairs

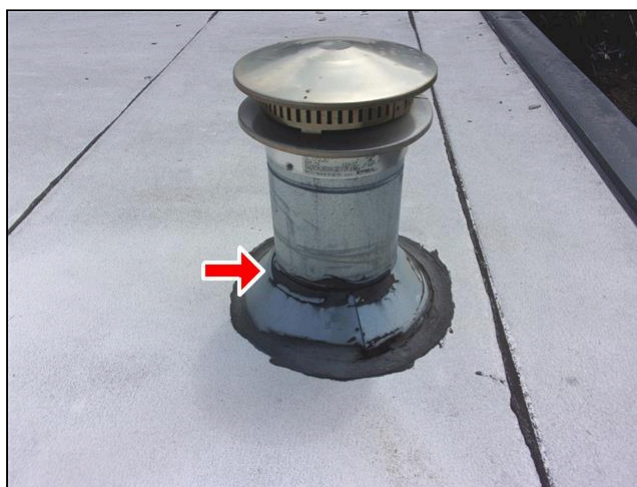
Gaps exist at the primary bedroom chimney vent stack roof flashing. This may allow rain water into the home causing damage. Have a qualified licensed roofing contractor properly seal the flashing to prevent potential leaking.

Gaps In Flashing

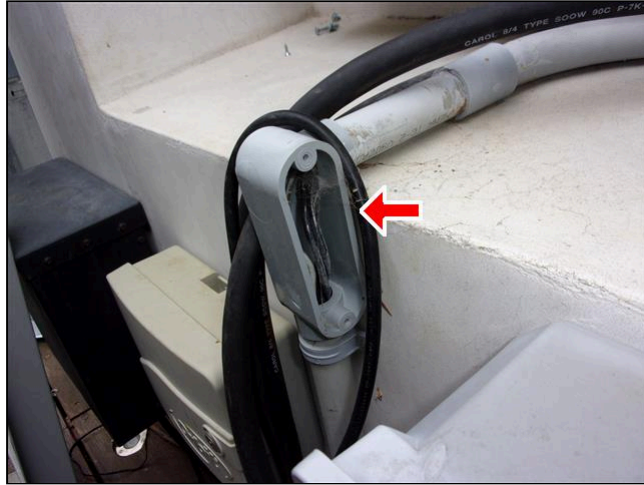
An open "L" electrical box exists at the rear exterior, under the main electrical panel. Have a qualified licensed electrician install a cover for safety.

Cover Plate Missing

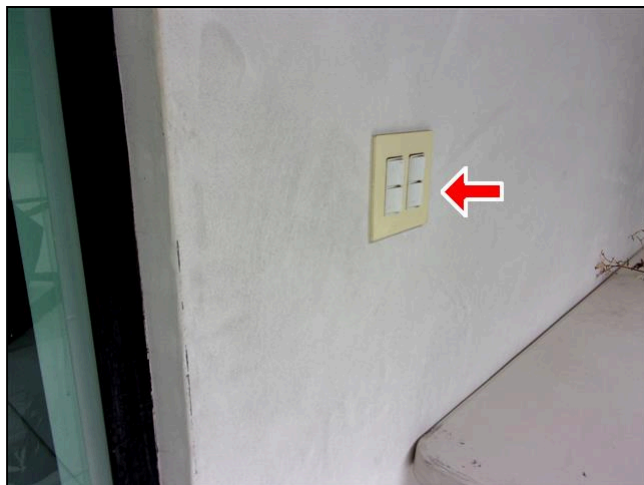
Exterior light switches at the left side covered patio area are missing weather rated covers. A qualified licensed electrical contractor should correct.

Weather Rated Cover Missing

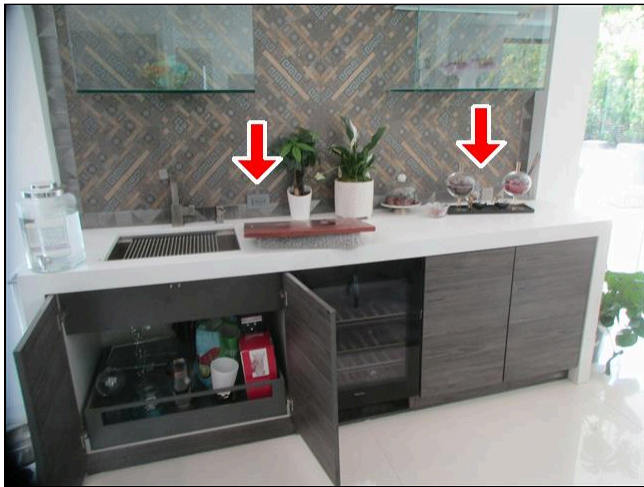
Electrical outlets were not operational between sinks in the primary bathroom, at the top level landing, at the beverage counter top in the kitchen, left side game room bathroom and 1st level powder room. Have a qualified licensed electrician evaluate and correct for proper operation.

Outlets Not Operational, Kitchen

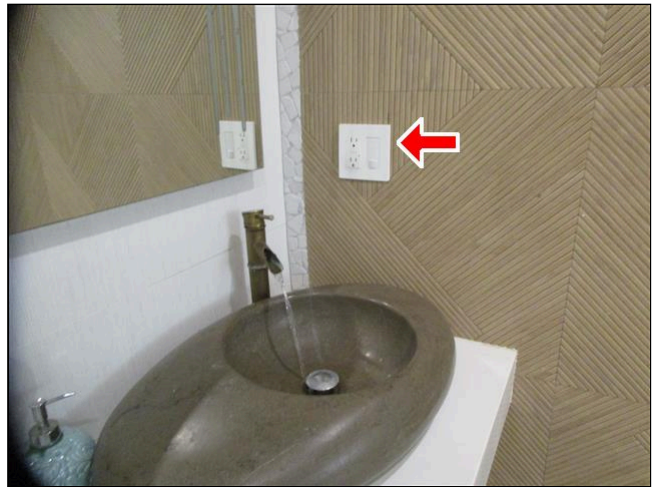
Outlet Not Operational, Game Room Bath
