## Inspection Report

**Property Address:**  
9774 San Cir  
Beverly Hills CA 90210

**Inspection Industries, LLC**

<b>Date:</b> 6/28/2023	<b>Time:</b> 10:00 AM	<b>Report ID:</b> 9774San
<b>Property:</b> 9774 San Cir Beverly Hills CA 90210	<b>Customer:</b> REvesty LLC	<b>Real Estate Professional:</b>

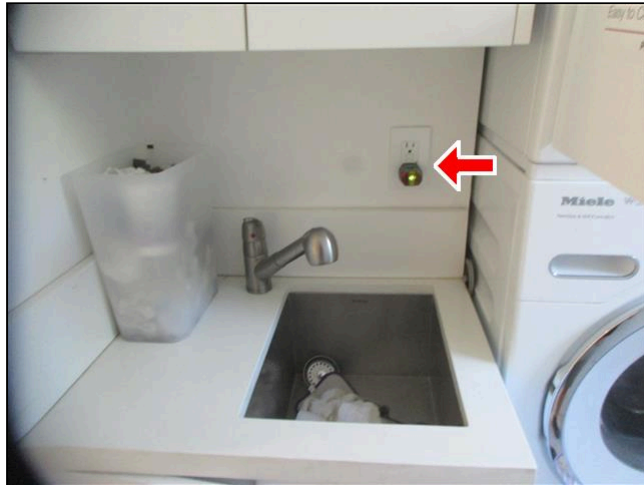
An electrical outlet tests with an open ground at the laundry room sink. This incorrect installation and is a safety issue that needs to be corrected by a qualified licensed electrical contractor.

Ungrounded Outlet

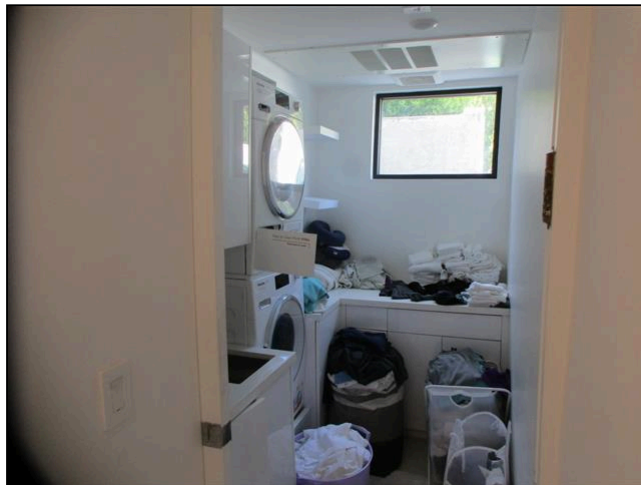
Note: The heat pump air handler for the 1st level right side was not accessible for inspection at the ceiling of the laundry room due to personal items. It's condition is not known and not represented in this report. This is for your information.

Air Handler Not Accessible

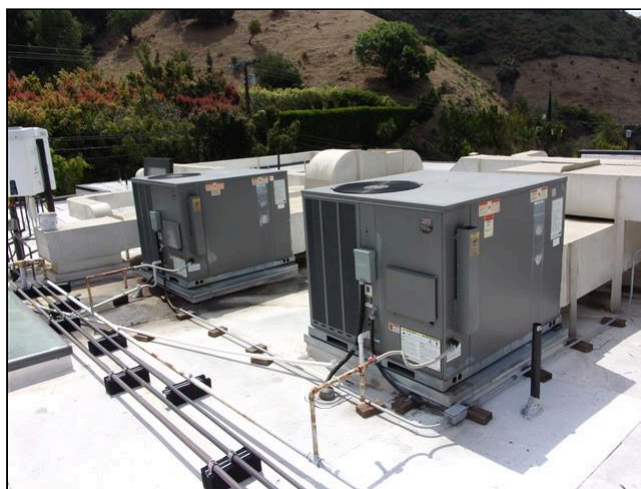
**NOTE:** All (4) HVAC systems were not able to be tested or operated as the thermostats were locked and the homeowner at the time of inspection insisted the systems were operational and refused to unlock for inspection purposes. The operability and conditions of the HVAC system are not known and not represented in this report. This is for your information.

HVAC Systems Not Tested

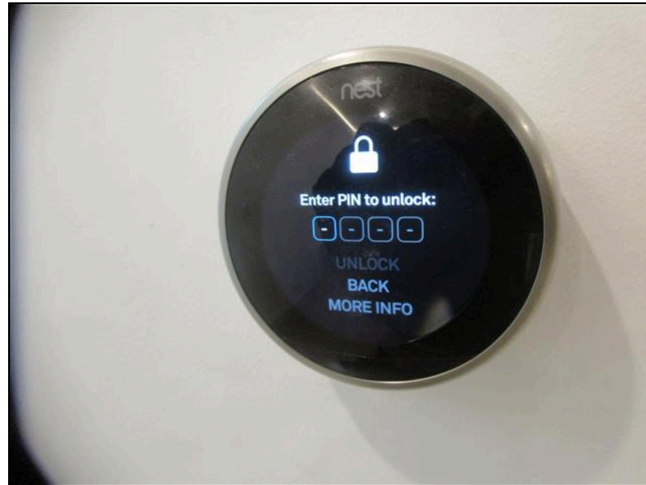
**NOTE:** All (4) HVAC systems were not able to be tested or operated as the thermostats were locked and the homeowner at the time of inspection insisted the systems were operational and refused to unlock for inspection purposes. The operability and conditions of the HVAC system are not known and not represented in this report. This is for your information.

T-Stats Locked

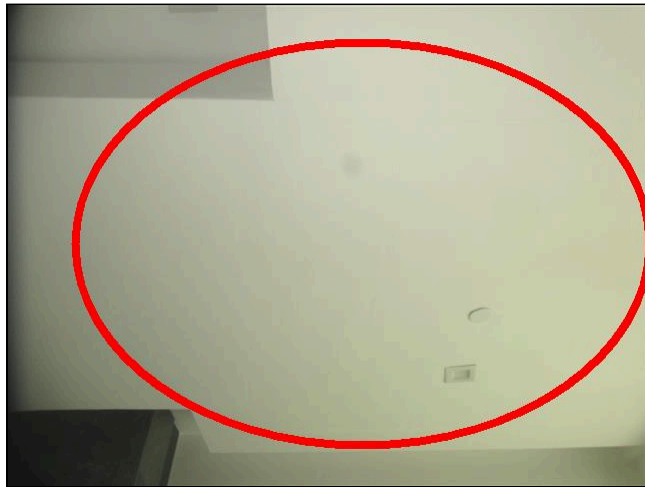
Ceilings reveal staining and damage in the living room, kitchen and garage. Leaking from the balconies/balcony doors and/or plumbing is suspected. Have a qualified licensed contractor evaluate further and perform all necessary repairs.

Stained, Damaged Ceiling, Living Room

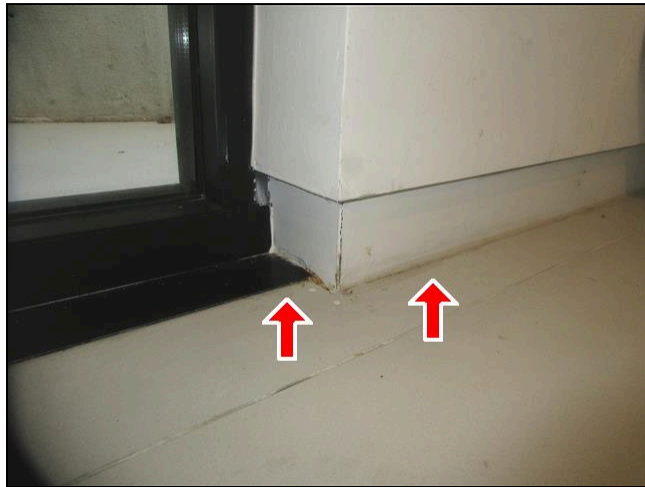
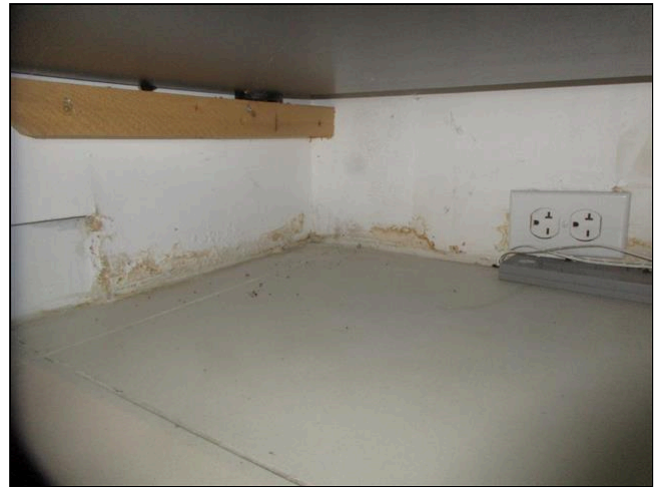
The front and right walls in the game room on the 1st level are stained at the floor from water intrusion. Leaking from the adjacent exterior staircase and landing is suspected. Have a qualified licensed contractor evaluate further and perform all necessary repairs.

Signs Of Water Intrusion

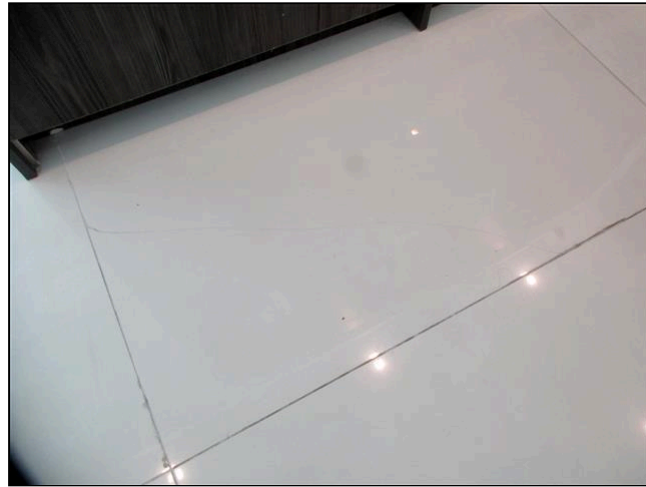
Tiles are loose and cracked in the kitchen. While this is cosmetic, it needs to be repaired by a qualified licensed contractor as needed.

Cracked, Loose Tiles, Kitchen

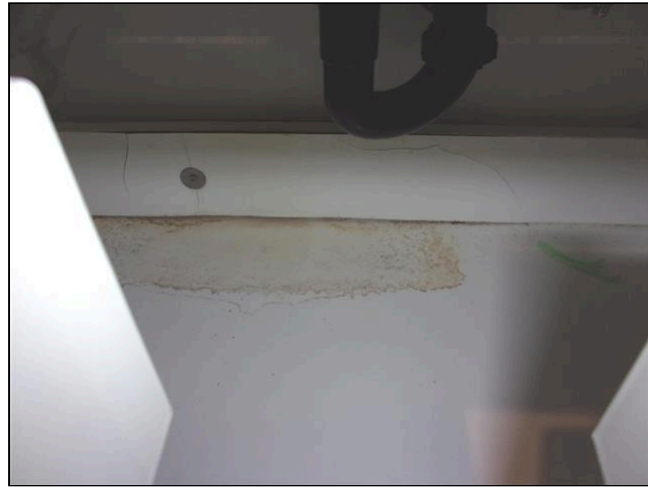
Old, dry stains were visible in the vanity of the right rear guest bathroom. The stains were dry at the time of inspection and appear to be from a previous leak that has been repaired. This is for your information.

Old, Dry Stains

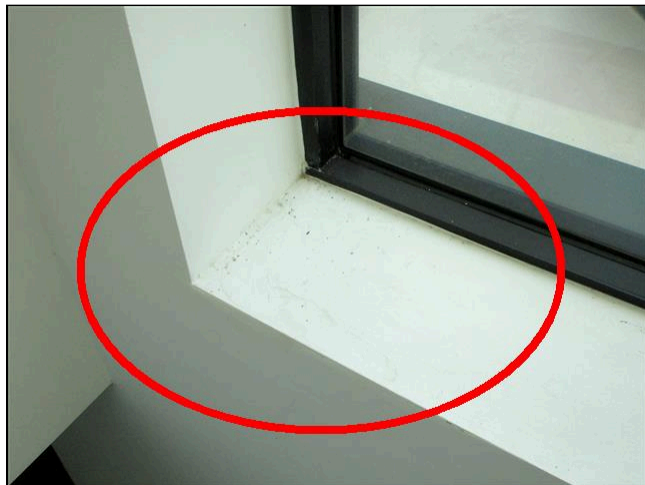
A window shows evidence of leaking at the jamb/sill at the rear wall of the main level entry. Water intrusion may continue to occur without correction. Have a qualified licensed window contractor repair as needed.

Signs Of Water Intrusion

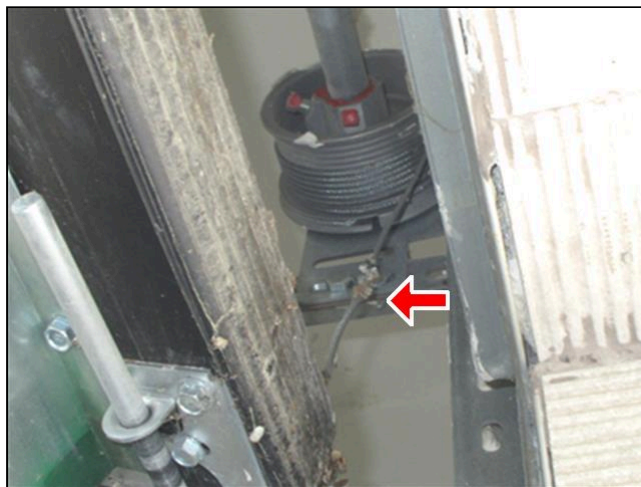
The garage vehicle door is not balanced. Tension is lost at the cables when the door is opened. This presents a safety hazard. Although the door opener was operational at the time of inspection, I recommend a qualified licensed garage door service company adjust/repair as necessary.

Loose Cables

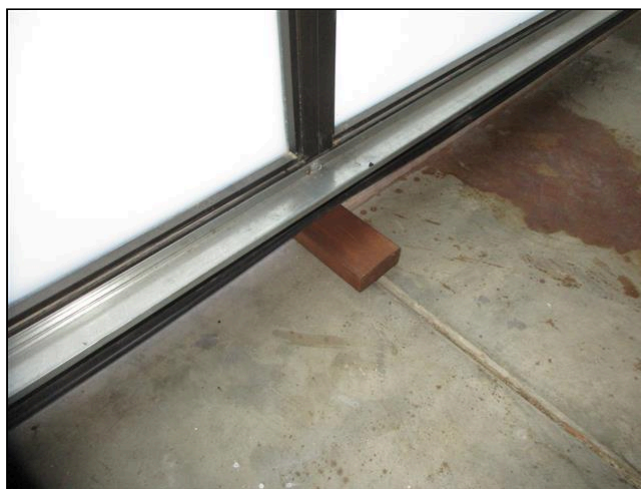
The automatic opener for the garage vehicle door will not reverse when met with resistance. This is considered unsafe and needs correcting by a qualified licensed garage door contractor.

Door Does Not Reverse

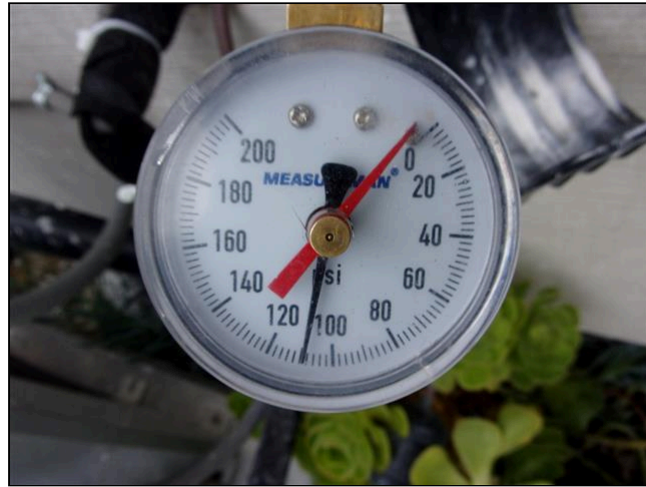
The static cold water pressure measured approximately 110psi at the exterior hose bibbs. Pressure above 80psi can cause leaking in the piping and fixtures of the home. Have a qualified licensed plumber adjust the pressure at the existing regulator valve accordingly.

High Pressure

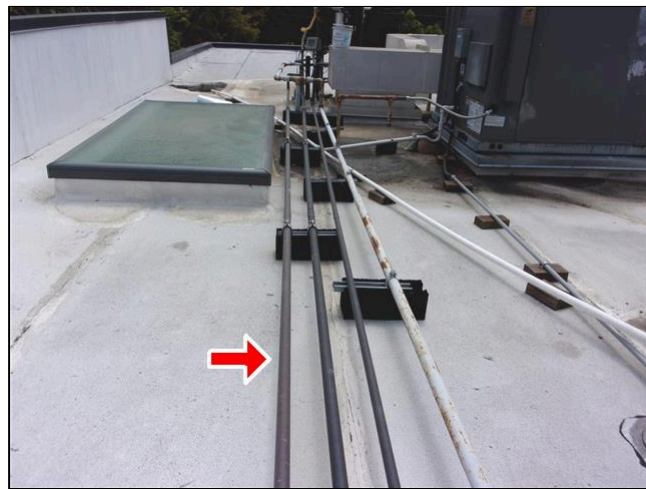
Water supply piping installed at the roof top has not been insulated. This piping is exposed to extreme temperatures which may cause fluctuations in the plumbing system. Today's standards typically required exposed piping be insulated. Have a qualified licensed plumber repair as needed.

Piping Not Insulated

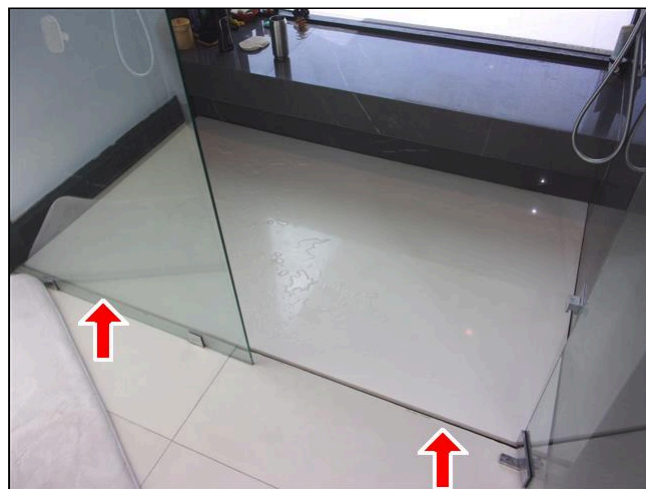
The entire shower pan floor is loose in the primary bathroom. This is incorrect installation and may allow leaking during operation of the shower. A qualified licensed contractor should evaluate further and perform all necessary repairs before continued use.

Loose Shower Pan

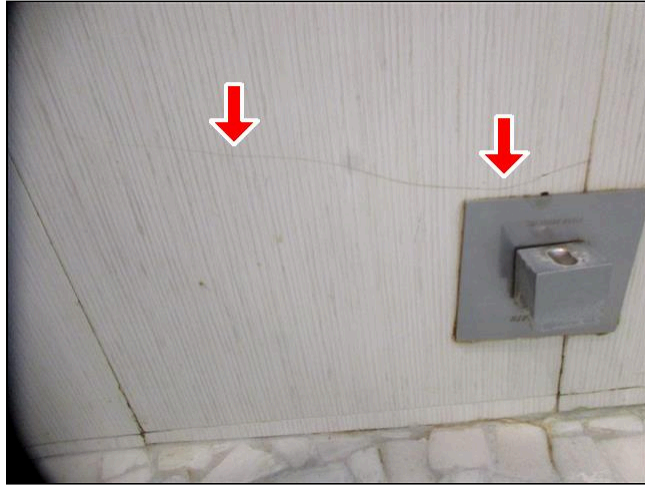
A cracked tile and loose drain cover were observed in the 1st level gym shower stall. A shower pan test should be performed by a qualified licensed contractor to determine if any leaking exists

Cracked Tile

and to perform all necessary repairs.

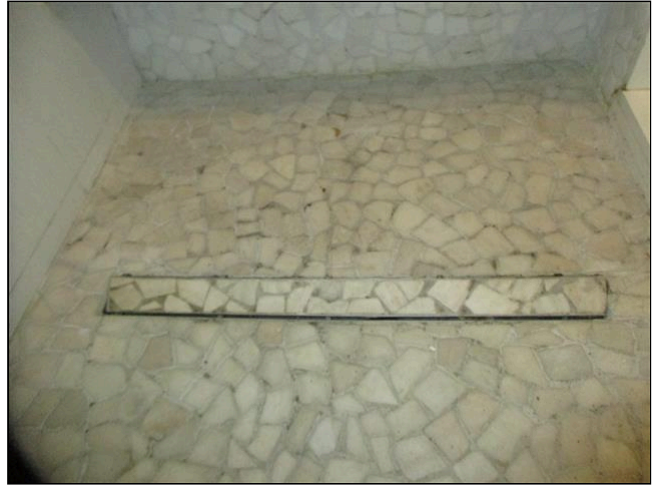
Loose Drain Cover

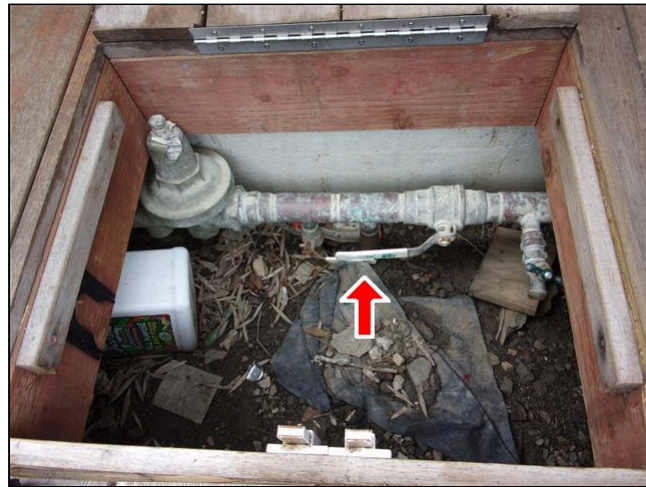
The main water shut off is the white lever located at the front exterior.

Water Shut Off Valve

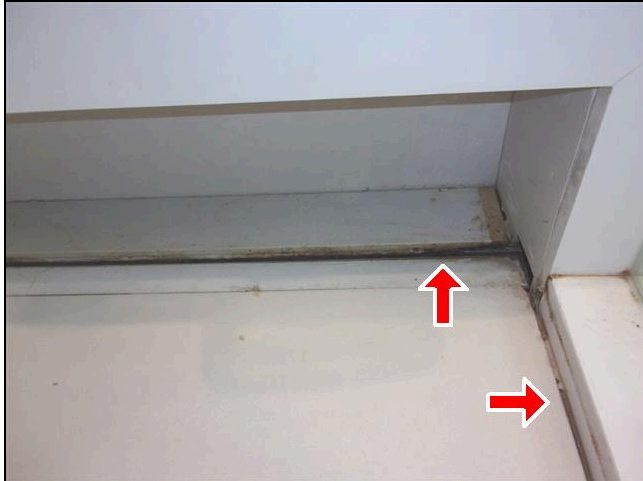
Suspected mold/fungus/mildew-like staining or substances were observed in the shower tile grout at the front left, front right and left side game room baths and on the garage ceiling. Analysis and testing for molds/fungus/mildew substances is not part of this general home inspection. I recommend evaluation and remediation by a qualified licensed contractor/hygienist/specialist in this field, as needed.

Suspected Mold/Fungus/Mildew, Front Left Guest Bath

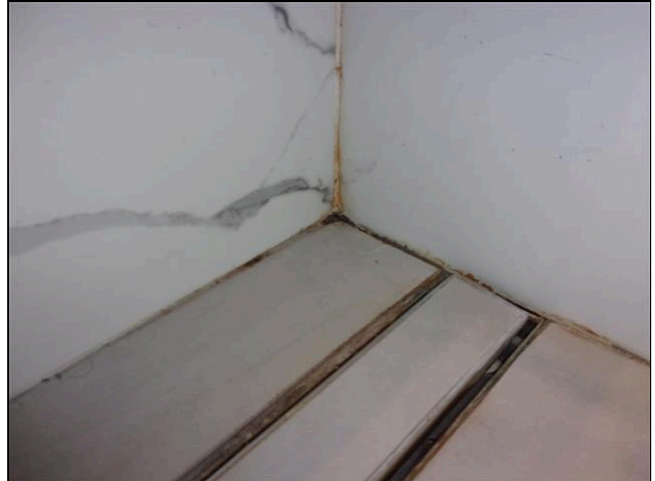
Suspected Mold/Fungus/Mildew, Front Right Bath

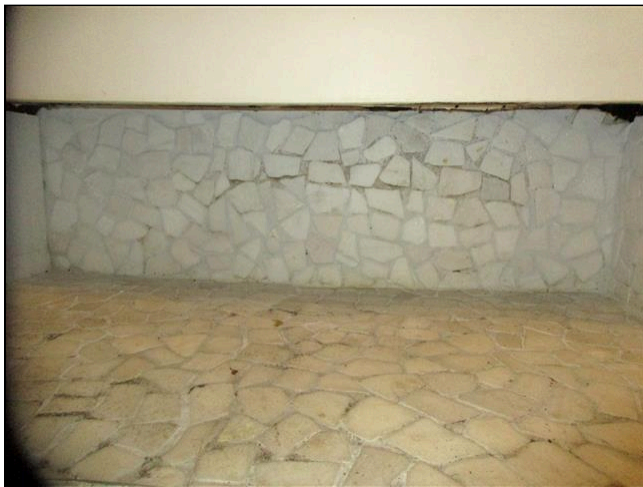
Suspected Mold/Fungus/Mildew, Left Game Room Bath

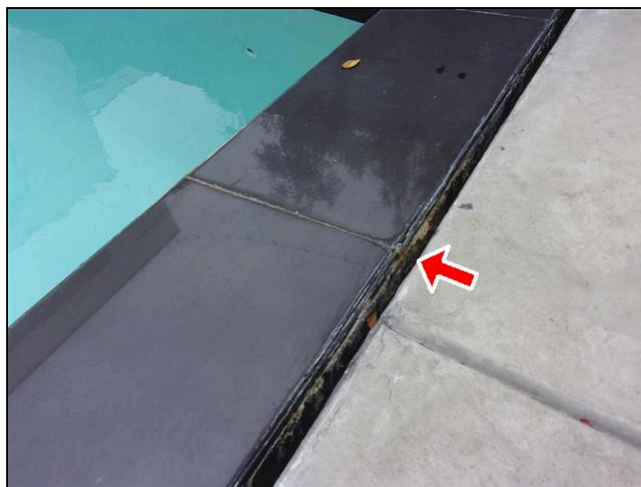
Tiles are loose around the pool & spa and the edges of the tiles are sharp at the top step of the spa. Loose tiles may allow leaking into surrounding materials and the sharp edges of the top step may cause injury. Have a qualified licensed pool contractor perform repairs as needed.

Loose Tiles

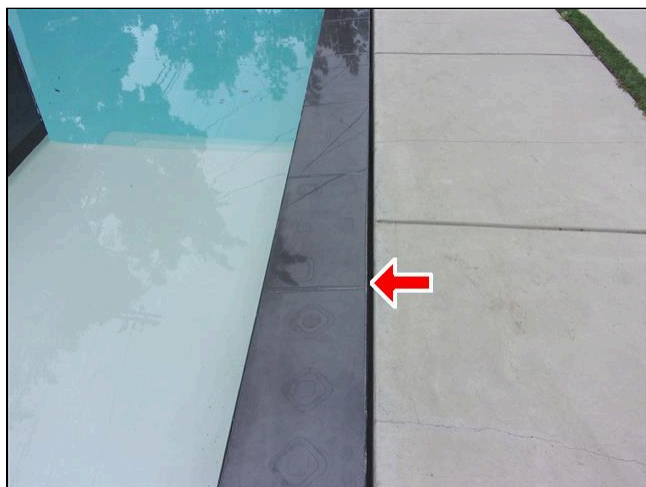
Loose Tiles

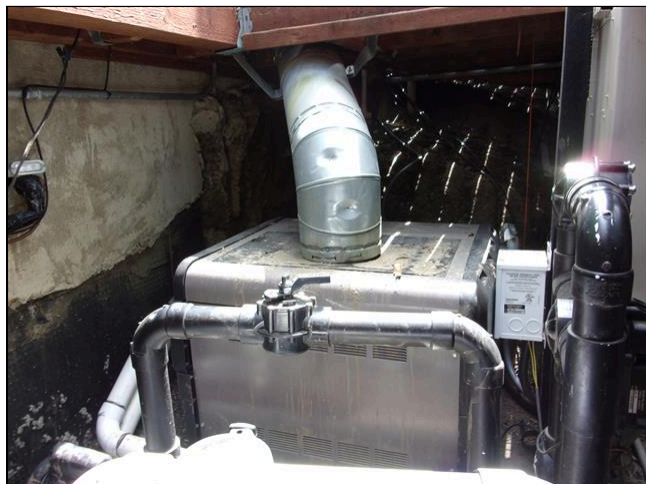
The pool/spa gas-fired heater failed to operate and the soil around the cabinet is too high. Have a qualified licensed pool contractor service and repair and clear away the soil for proper operation.

Heater Not Operational

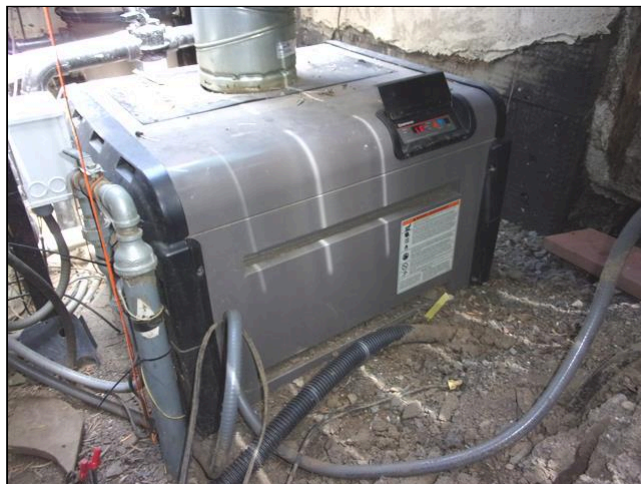
Soil Too High

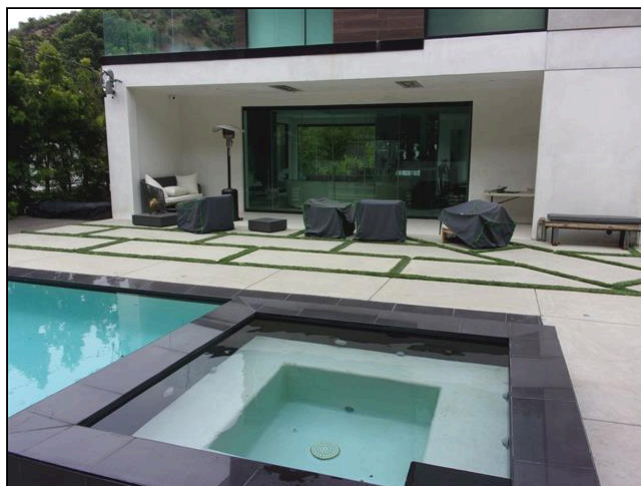
The exterior doors allow direct access from the house to the pool/spa area. This is a significant safety and childproofing issue. I recommend you have a qualified licensed pool contractor properly install an enclosure, fencing, cover, door alarms, water surface alarm and/or childproof locks as necessary.

Direct Access To Pool/Spa Area

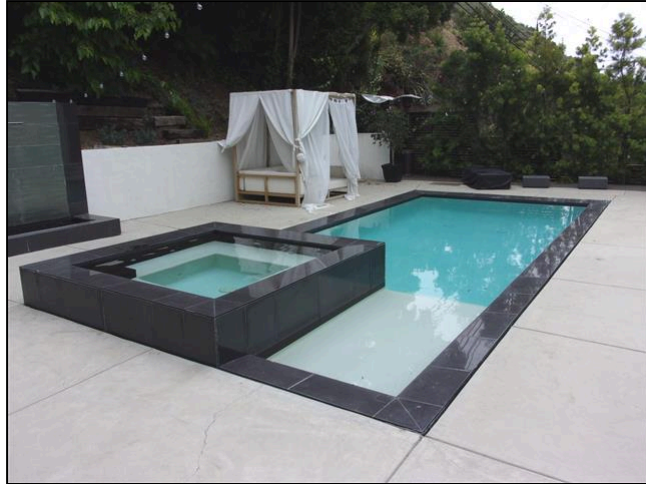
There are fewer than 2 drowning prevention safety features present regarding access to the pool/spa. At least 2 of the following safety features are now required to meet today's standards: a proper barrier/ enclosure, self closing self latching exterior doors, pool/spa safety cover, door exit alarms or water surface alarm are safety features. Contact a qualified licensed pool contractor for options, costs and installation for safety.

Less Than 2 Drowning Prevention Features Present
