Inspection Report

Property Address:
27011 Rocking Horse Ln
Laguna Hills CA 92653

Date: 6/24/2023	Time: 10:00 AM	Report ID: 27011Horse
Property: 27011 Rocking Horse Ln Laguna Hills CA 92653	Customer: REvesty LLC	Real Estate Professional: Niko Trimino

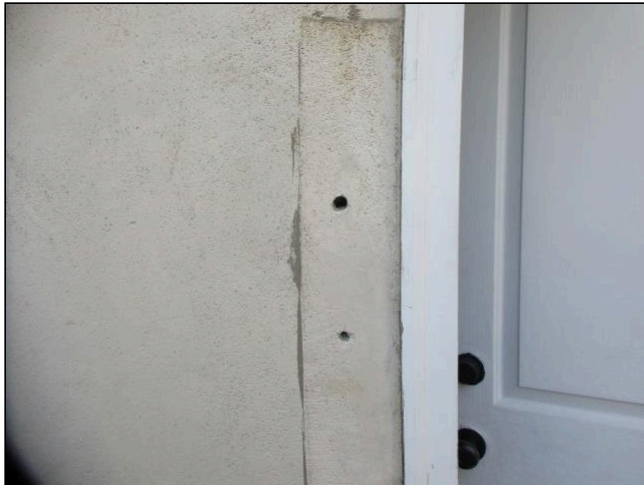
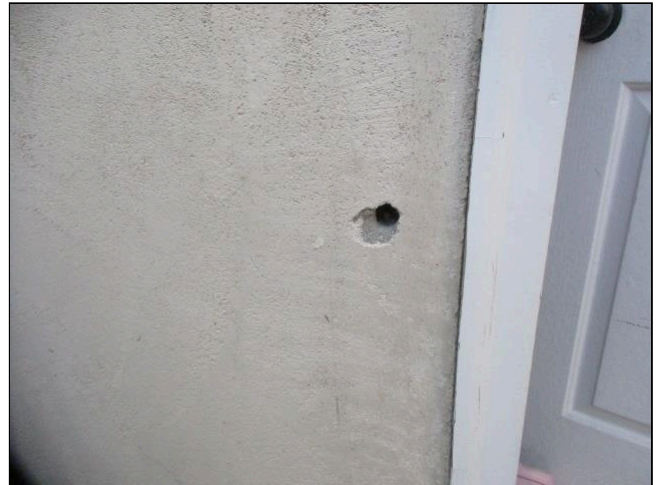
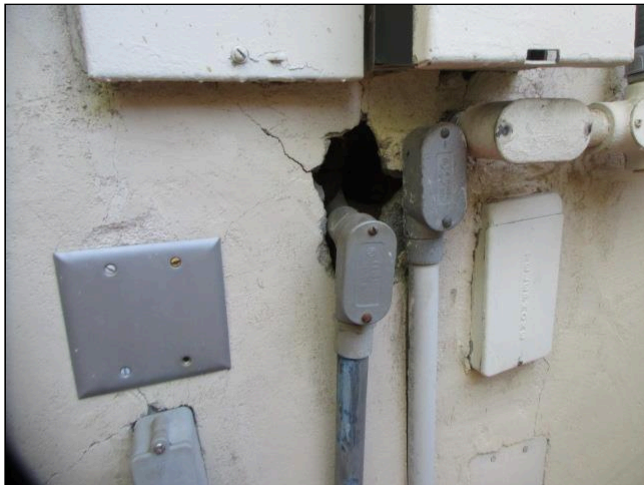
- 1** Openings/holes exist in the stucco siding at the right side of the garage. The openings need to be sealed and repaired to prevent moisture intrusion.

Holes In Stucco

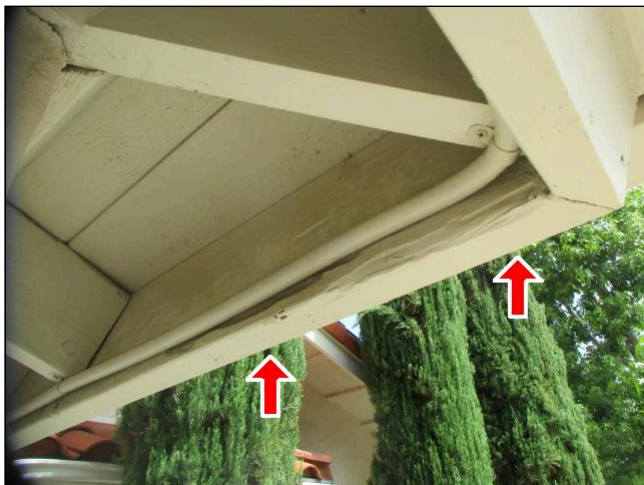
- 2 The wood fascia is damaged at the front outside the office and wood window banding is damaged outside a family room window next to the slider. Have a qualified licensed contractor repair as needed.

Damaged Fascia, Front

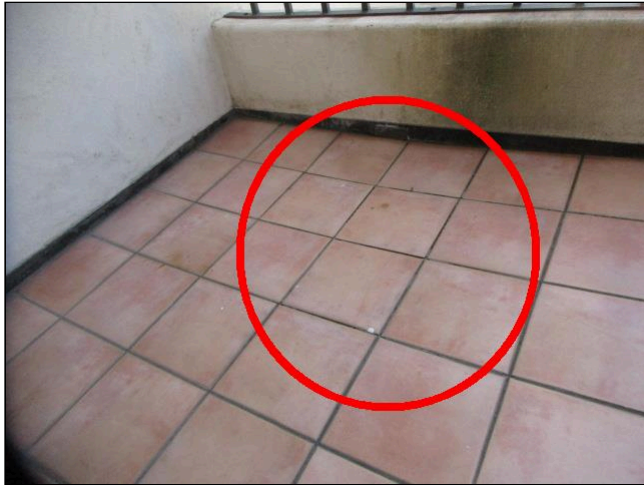
- 3 The balcony surfaces have soft spots and loose tiles at the rear guest bedroom and upstairs loft. Water intrusion can cause further damage if not repaired and sealed properly. A qualified licensed contractor should evaluate and repair as needed.

Weak Balcony Surface, Rear Guest Bedroom

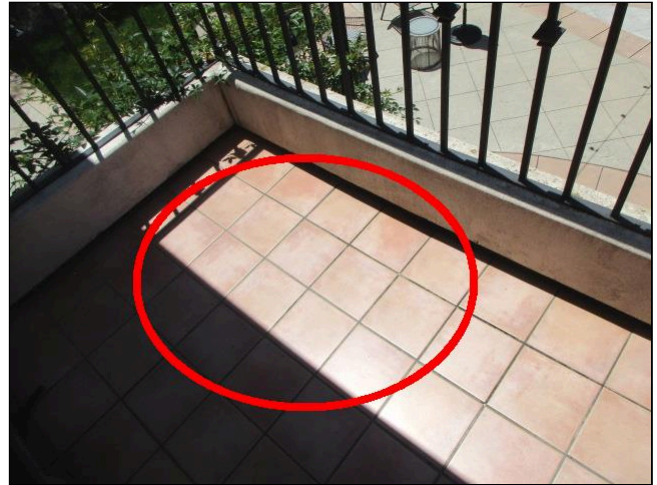
Weak Balcony Surface, Loft

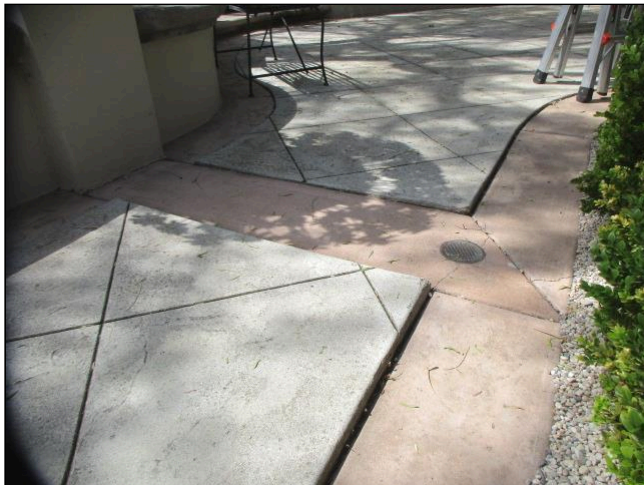
- 4 The concrete drive, walks and patio surfaces have heaved throughout the property. This presents tripping hazards and may cause a fall or injury if not corrected. Have a qualified licensed contractor repair or replace as needed.

Heaved Walk, Front

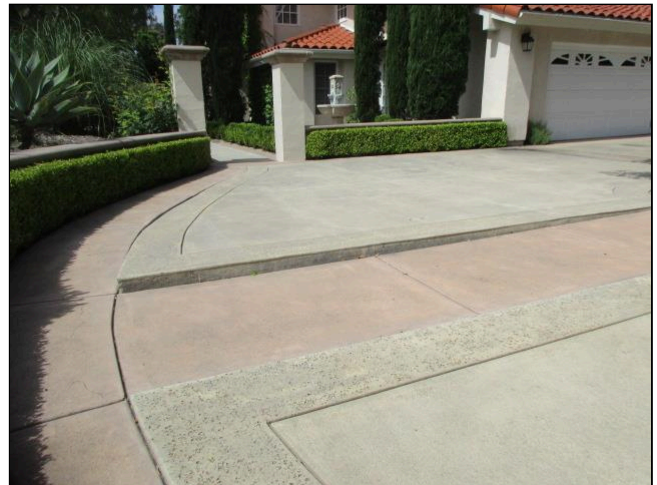
Heaved Drive

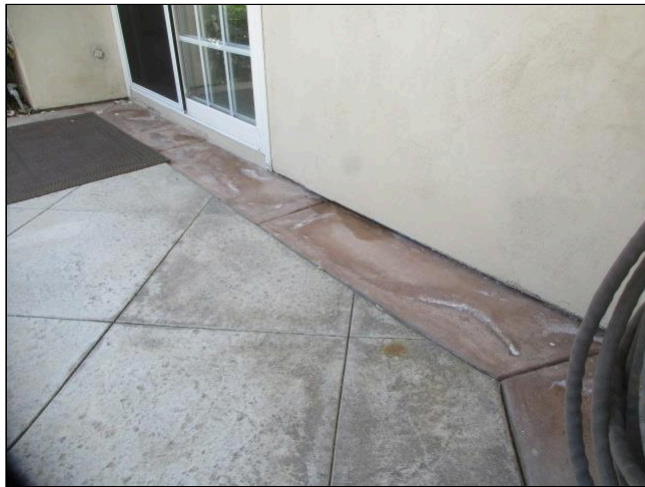
- 5 The concrete patio surface is incorrectly sloped at the left side of the home. This will allow standing water and if not corrected water intrusion and/or damage may occur. Have a qualified licensed contractor correct the hardscaped surface and/or extend the in-ground drainage system so that water can be properly controlled and drained away from the home.

Patio Sloped Toward Home, Poor Drainage

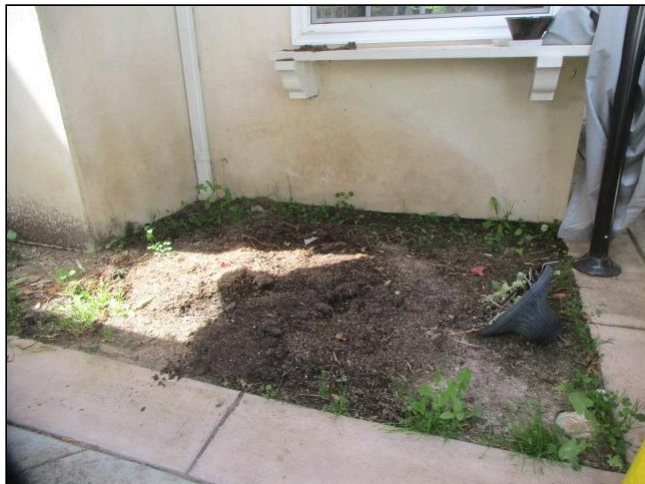
- 6 Landscape soils are too high against the exterior stucco siding at the left and rear sides of the home. This can allow water intrusion and damage to the walls if not corrected. Lower the soil levels in the flower beds, 6"-8" below the stucco weep screed is preferable.

Soils Too High, Rear

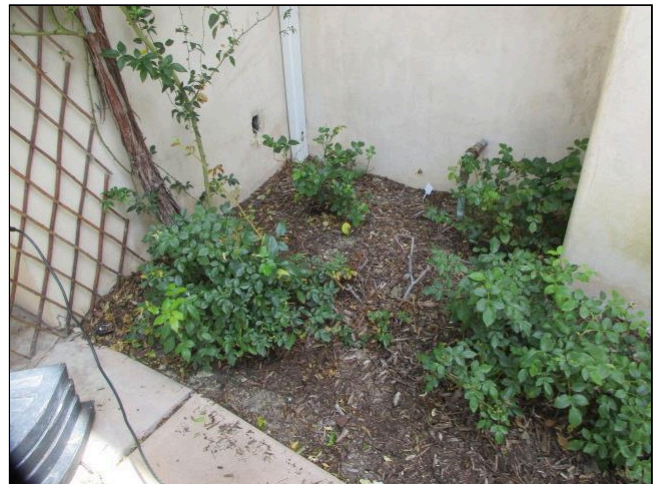
Soils Too High, Left Side

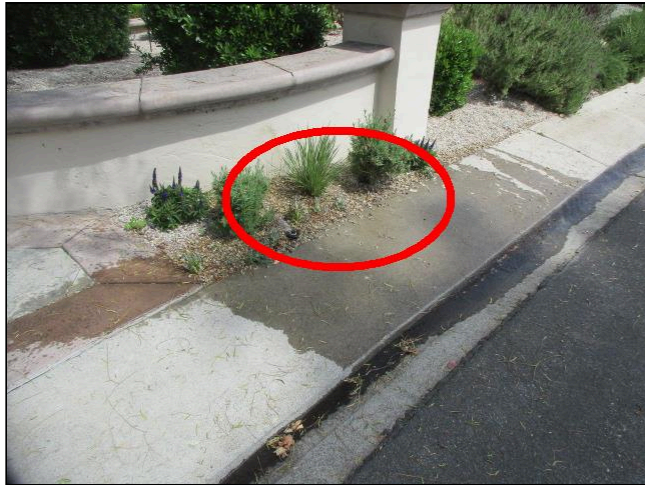
- 7 Leaking from underground sprinkler piping was observed during operation at the Rocking Horse street flower bed and active leaking from a sprinkler valve was observed against and into the garage. Water intrusion can damage surrounding materials if not repaired. Have a qualified landscape contractor repair as needed.

Leaking Sprinkler Piping

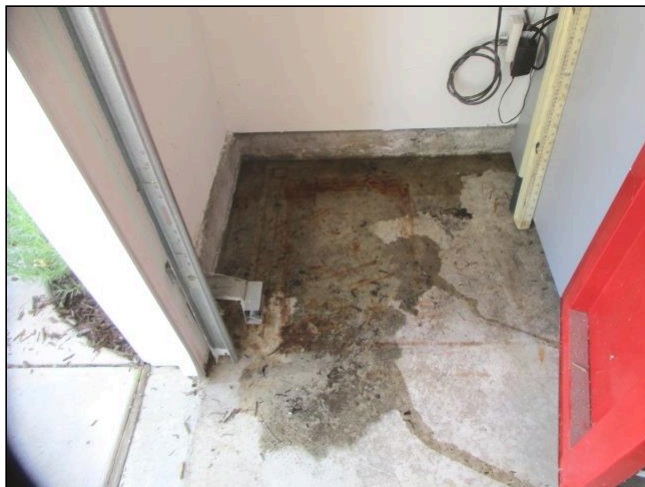
Leaking Sprinkler Valve

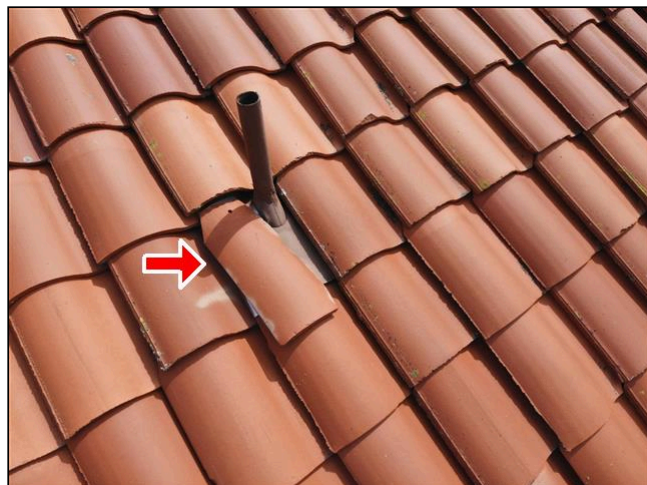
- 8 Several broken tiles at the right side of the roof and a loose/displaced tile at the left side of the roof and staining on the plywood sheathing was observed at the center of the attic, under the left side of the roof. Have a qualified licensed roofing contractor evaluate and repair as needed.

Loose Tile, Left Side

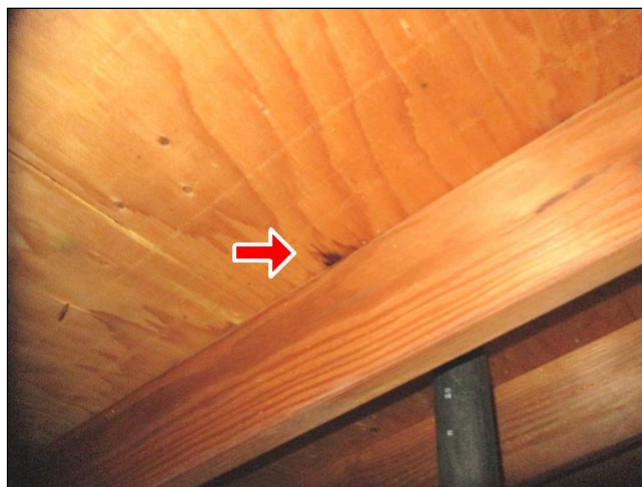
Stained Plywood

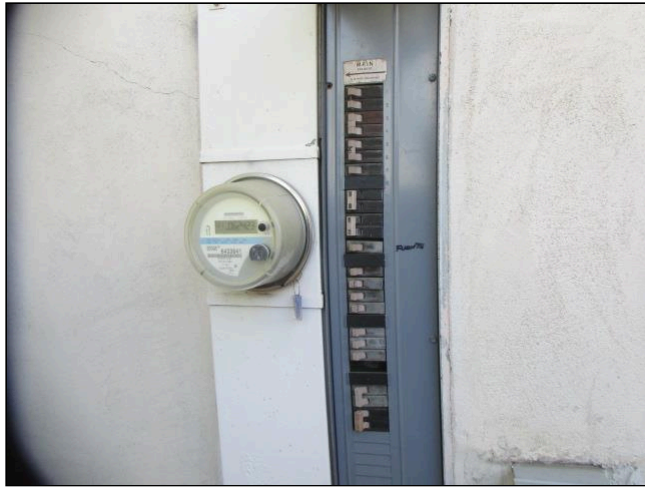
- 9 The main electrical panel and pool/spa sub electrical panel are not labeled. This is required by today's standards. Repair as needed.

Labeling Missing

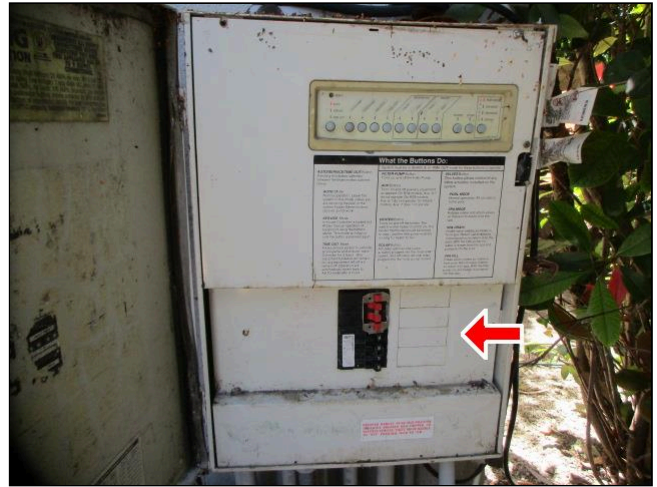
Labeling Missing

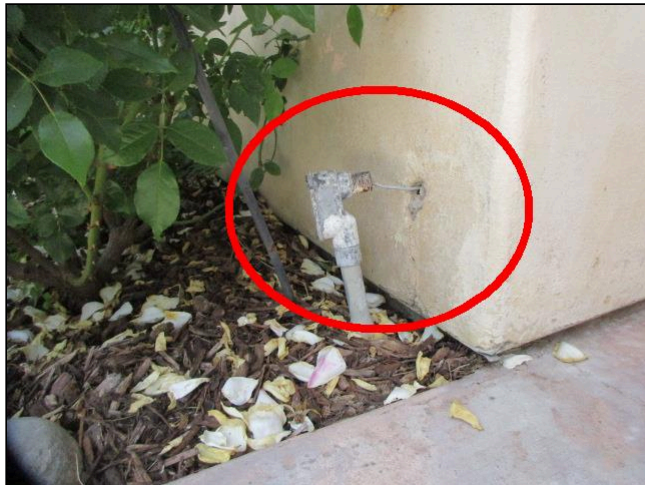
- 10** Loose conduit and exposed wiring was observed in the flower bed outside the kitchen sliding glass door. Have a qualified licensed electrician repair or remove for safety as needed.

Loose Conduit, Exposed Wiring

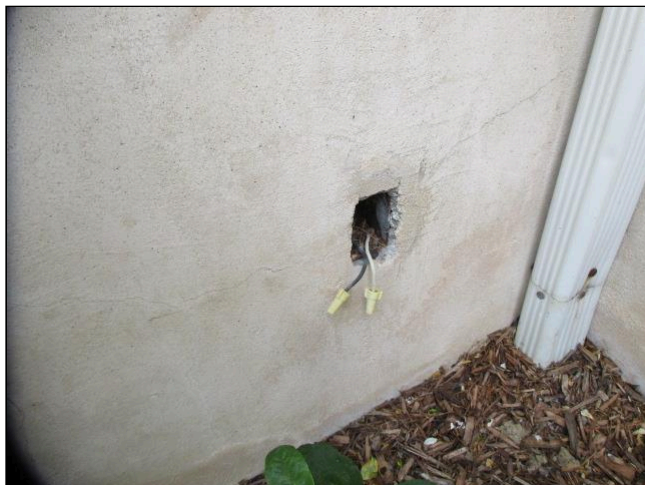
- 11** An open electrical junction box or missing outlet exists at the left side of the home, outside the living room. This exposes wiring to contact and is a shock hazard. Have a qualified licensed electrician repair for safety.

Exposed Wiring At Open Box

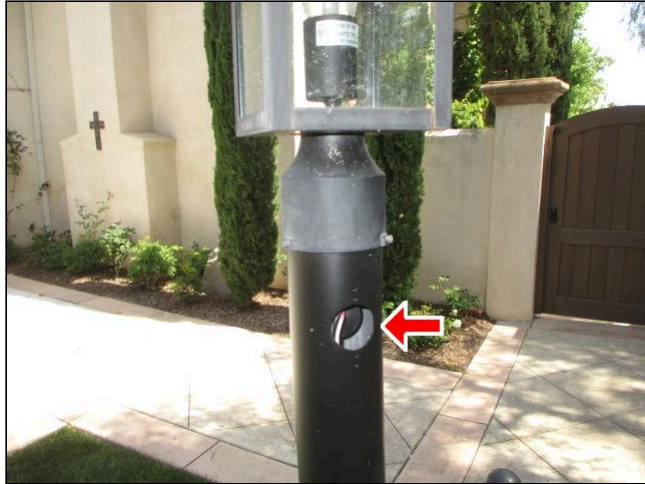
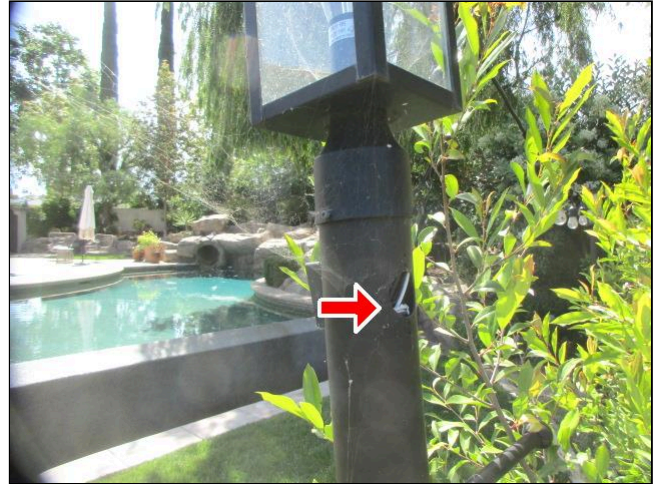
- 12 Exposed electrical wiring is present at several of the post lights where cover plates are missing, around the pool/spa area. Have a qualified licensed electrician repair for safety.

Exposed Wiring

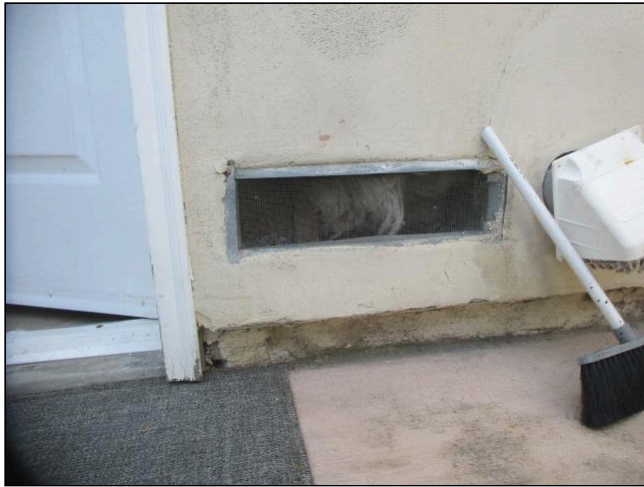
- 16** Wall vents are blocked/covered at the right side of the garage. Open the vents to allow for proper air circulation into the garage.

Garage Vents Blocked/Covered

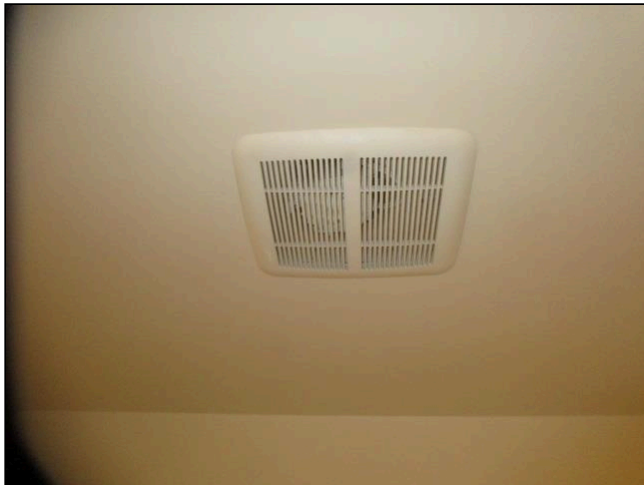
- 17** The exhaust fan did not work in the downstairs guest bath. Have a qualified licensed contractor repair or replace for proper ventilation as needed.

Fan Not Operational

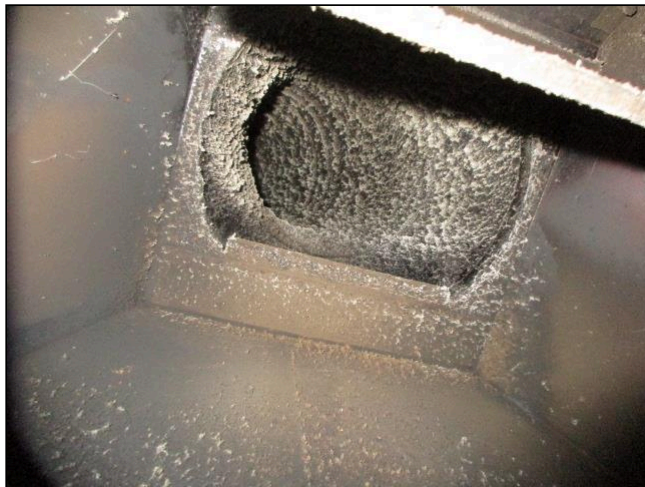
- 19** A build-up of creosote is present in the primary bedroom fireplace at the damper, smoke chamber & chimney. Contact a qualified chimney sweep service to clean the fireplace and chimney for safe use.

Creosote, Primary Bedroom

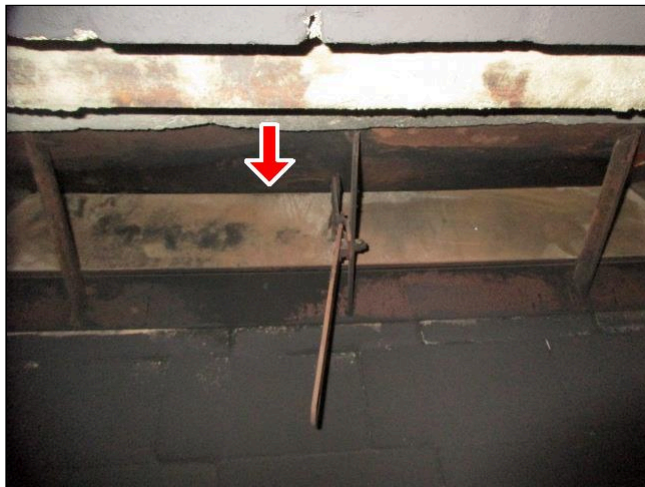
- 21 The damper for the living room and family room fireplaces is missing a clamp or lock that forces the lid to stay open. Without a clamp to force open the damper, it could allow unsafe carbon monoxide to enter the home. Install for safety.

Add Damper Lock, Living Room

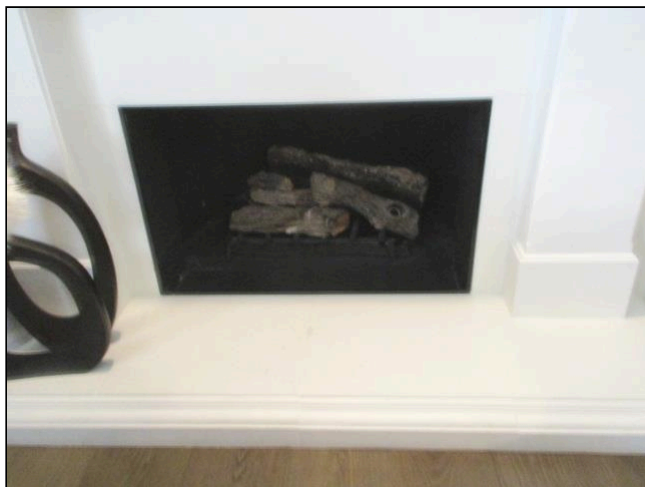
- 22 Doors or screens are missing at the opening of the living room fireplace. This is necessary to help prevent embers from escaping the firebox during use. Install doors or screens as necessary.

Add Doors/Screens

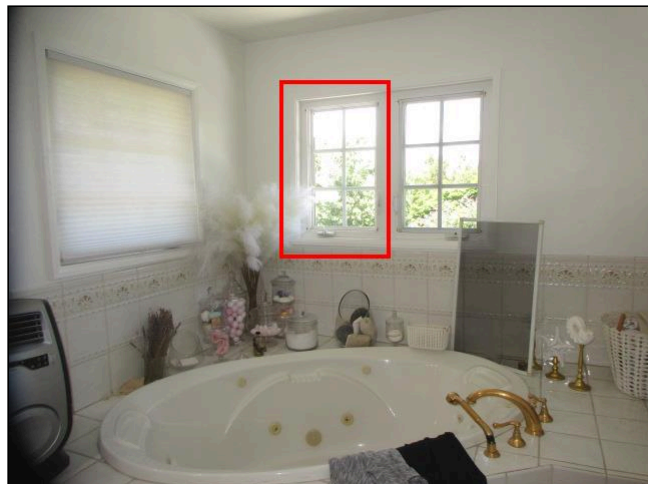
- 23** A window over the primary bath tub is not tempered safety glass. This is a slip & fall injury hazard; glass around a tub/shower will break into large shards when broken if it is not tempered glass. Have a qualified licensed window contractor repair for safety.

Glass Not Tempered

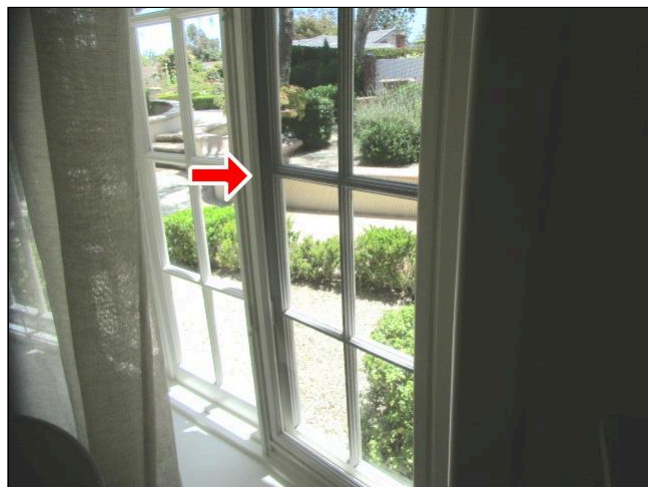
- 24** Two wood casement windows bind in the frames and do not open at the living room bay windows. Have a qualified licensed window contractor repair as needed.

Windows Bind, Do Not Open

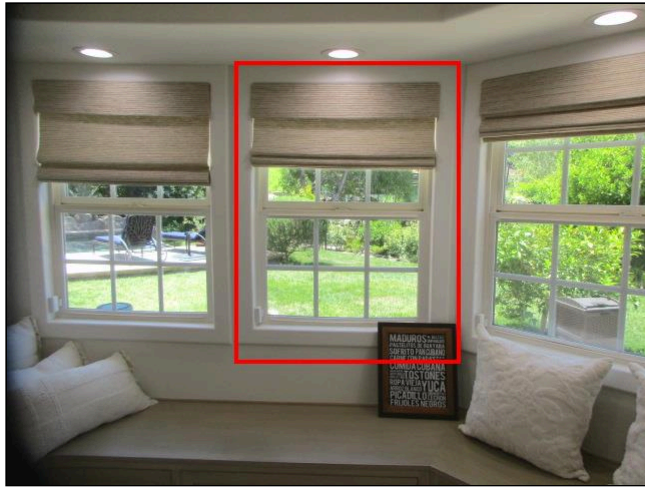
- 25** A single hung window has a faulty channel balance and no longer opens properly at the left wall of the breakfast nook. Have a qualified licensed window contractor repair for proper operation.

Faulty Channel Balance

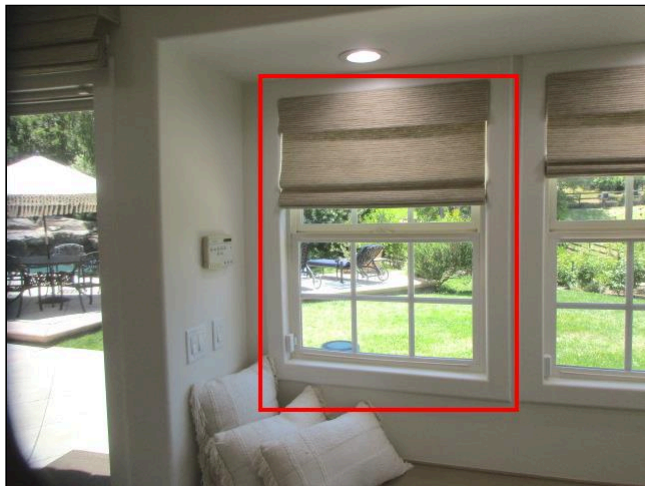
- 26 A single hung window has a broken lock handle at the left wall of the breakfast nook. Have a qualified licensed window contractor repair for proper operation as needed.

Broken Lock

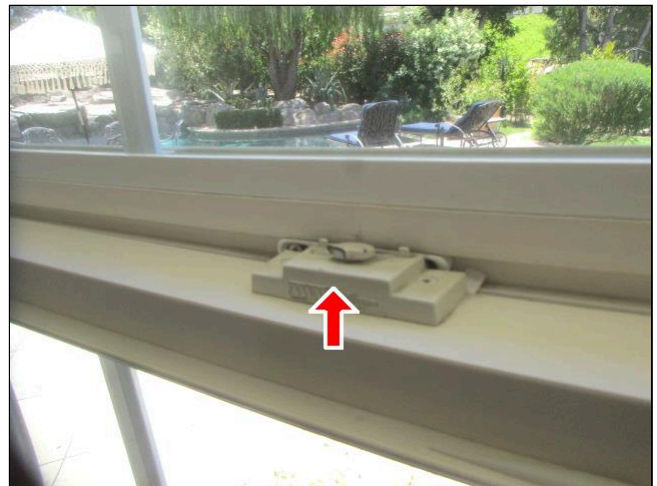
Broken Lock

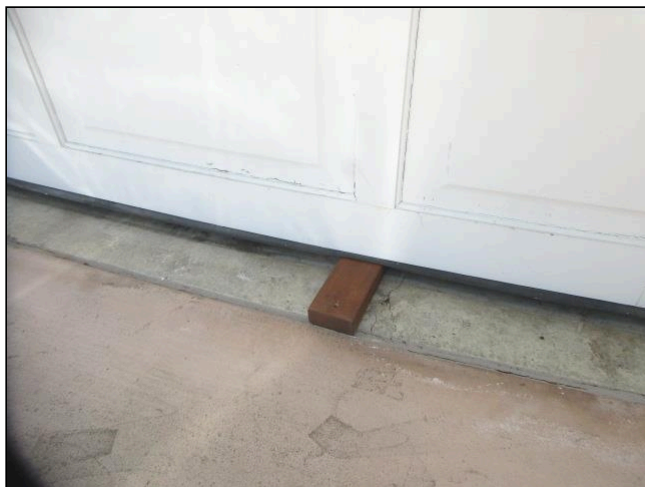
- 28** The automatic opener for the double car garage vehicle door will not reverse when met with resistance. This is considered unsafe and needs correcting by a qualified licensed garage door contractor.

Door Does Not Reverse

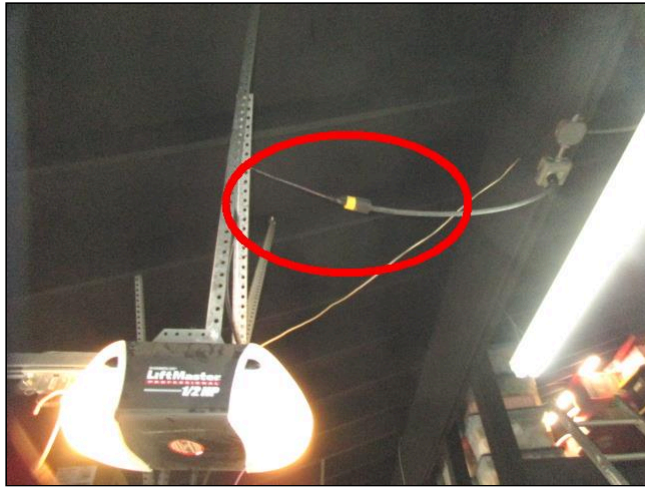
- 29** The automatic openers for the single car and double car garage doors are using an extension cord as permanent wiring and should have its own dedicated outlet. This is considered unsafe and needs correcting by a qualified licensed electrician.

Extension Cords In Use

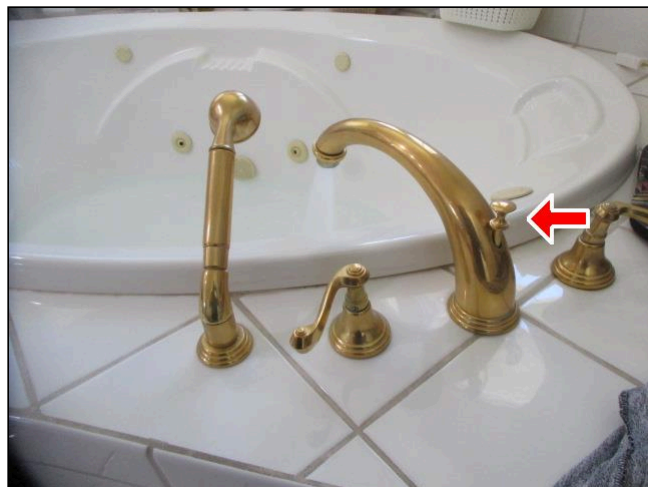
- 31** The tub spout/wand diverter does not operate at the primary bathroom. A qualified licensed plumber should repair as needed.

Diverter Not Operational

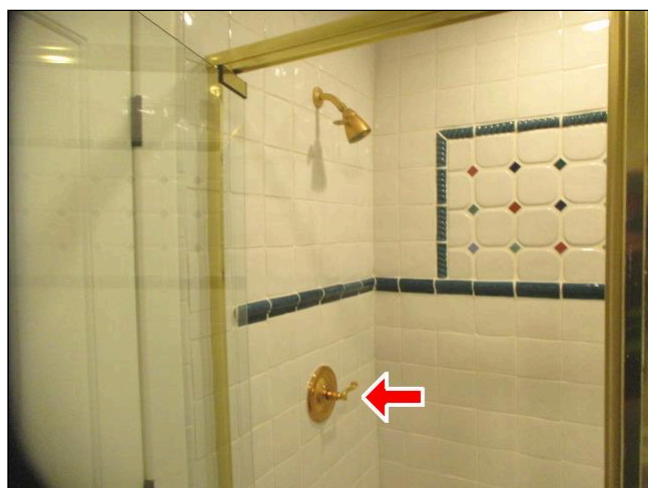
- 32 The shower faucet does not operate in the downstairs guest bath. A qualified licensed plumber should repair as needed.

Shower Faucet Not Operational

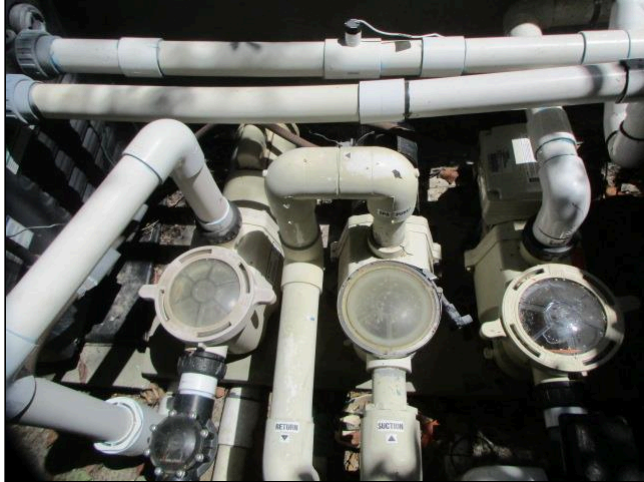
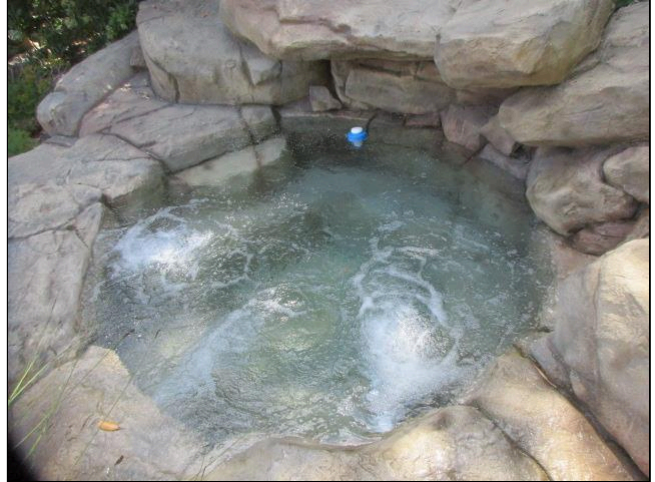
- 34 The spa booster pump did not operate properly when tested with manual controls. Have a qualified licensed pool contractor review and repair or replace to ensure proper operation.

Spa Booster Pump Not Operating Properly

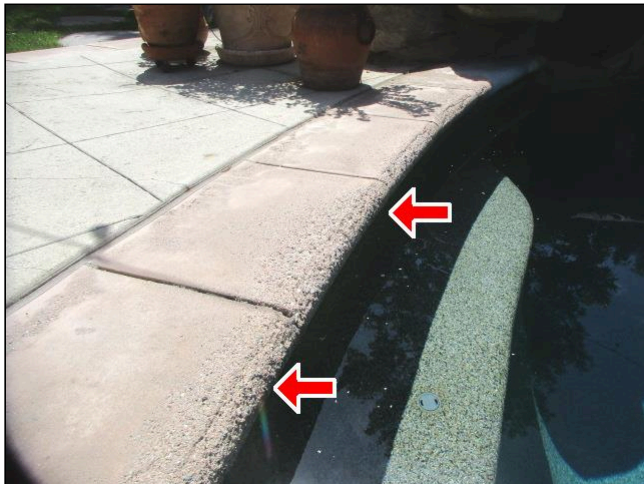
- 35 Damage to the pool coping and sidewalls of the collection area were observed. Have a qualified licensed pool contractor repair as needed.

Damaged Coping

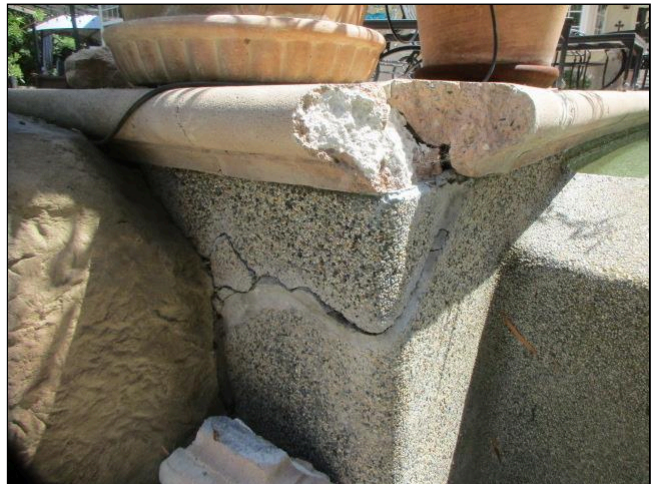
Damaged Coping, Sidewall

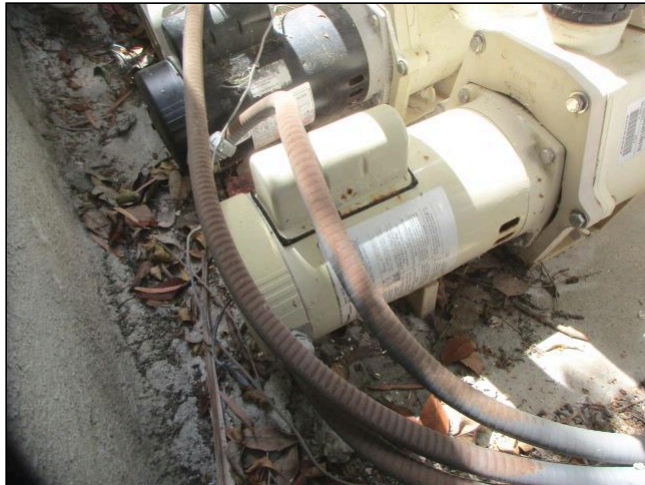
- 36 The circulation, waterfall and spa booster pumps are not properly bonded to ground. This is a safety feature that should be repaired by a qualified licensed pool contractor in case of an electrical fault.

Pumps Not Bonded To Ground

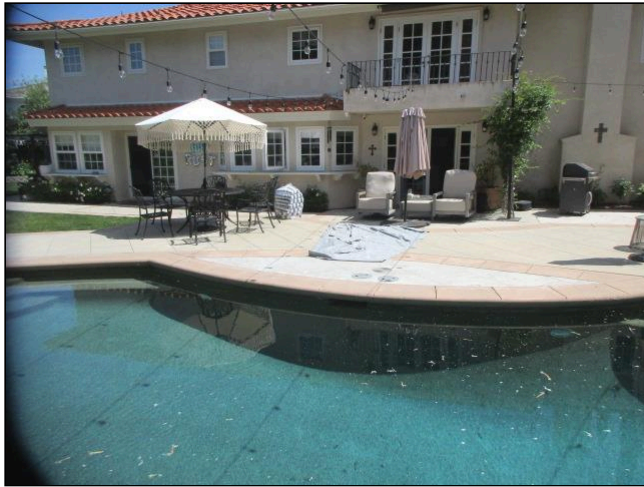
38 The exterior doors allow direct access from the house and garage to the pool/spa area. This is a significant safety and childproofing issue. I recommend you have a qualified licensed pool contractor properly install an enclosure, fencing, cover, door alarms, water surface alarm and/or childproof locks as necessary.

Direct Access To Pool/Spa

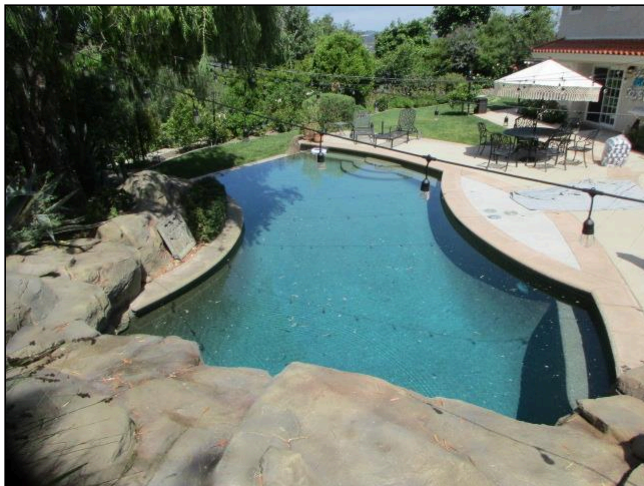
- 39** There are fewer than 2 drowning prevention safety features present regarding access to the pool/spa. At least 2 of the following safety features are now required to meet today's standards: a proper barrier/enclosure, self closing self latching exterior doors, pool/spa safety cover, door exit alarms or water surface alarm are safety features. Contact a qualified licensed pool contractor for options, costs and installation for safety.

Less Than (2) Drowning Prevention Features Present

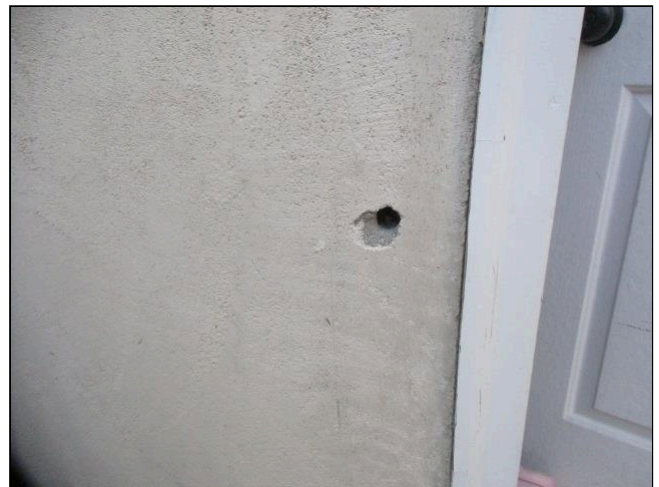
Openings/holes exist in the stucco siding at the right side of the garage. The openings need to be sealed and repaired to prevent moisture intrusion.

Holes In Stucco

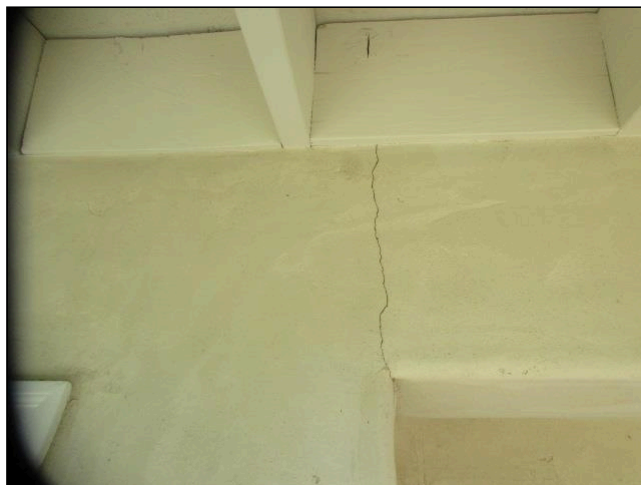
Cracking is present at some areas of the stucco siding. This is usually a sign of normal settlement or shrinkage of the material. Consider sealing the cracking to maintain a water tight exterior.

Stucco Cracks

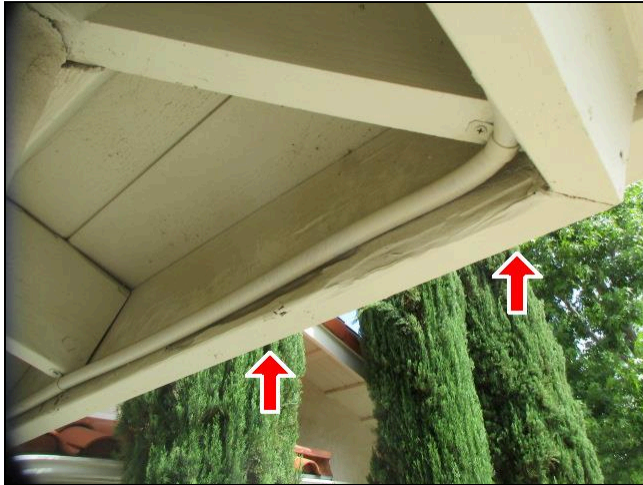
The wood fascia is damaged at the front outside the office and wood window banding is damaged outside a family room window next to the slider. Have a qualified licensed contractor repair as needed.

Damaged Fascia, Front

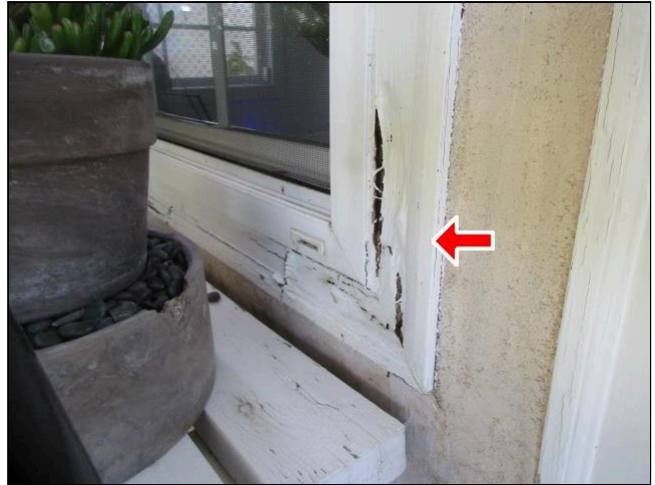
Damaged Window Banding, Family Room

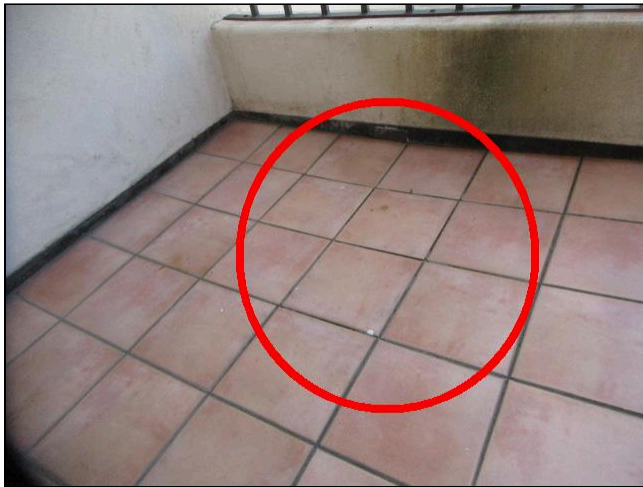
The balcony surfaces have soft spots and loose tiles at the rear guest bedroom and upstairs loft. Water intrusion can cause further damage if not repaired and sealed properly. A qualified licensed contractor should evaluate and repair as needed.

Weak Balcony Surface, Rear Guest Bedroom

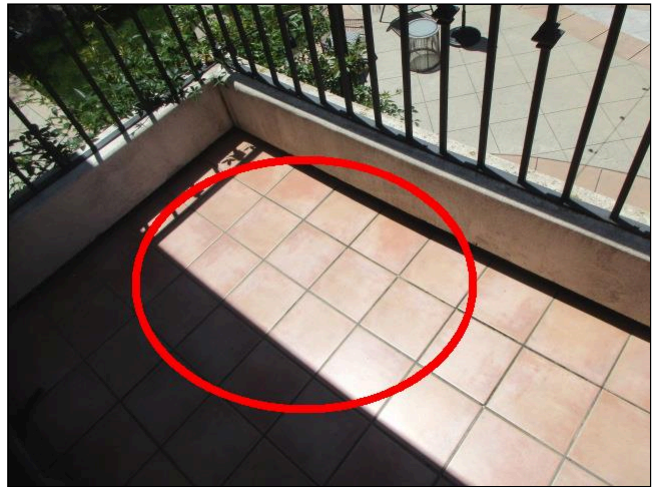
Weak Balcony Surface, Loft

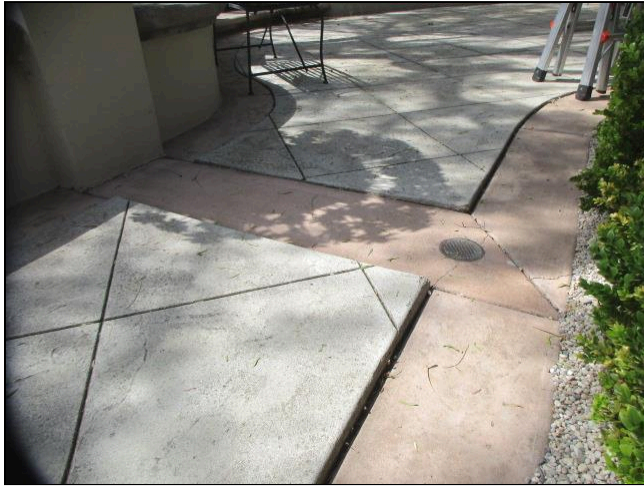
The concrete drive, walks and patio surfaces have heaved throughout the property. This presents tripping hazards and may cause a fall or injury if not corrected. Have a qualified licensed contractor repair or replace as needed.

Heaved Walk, Front

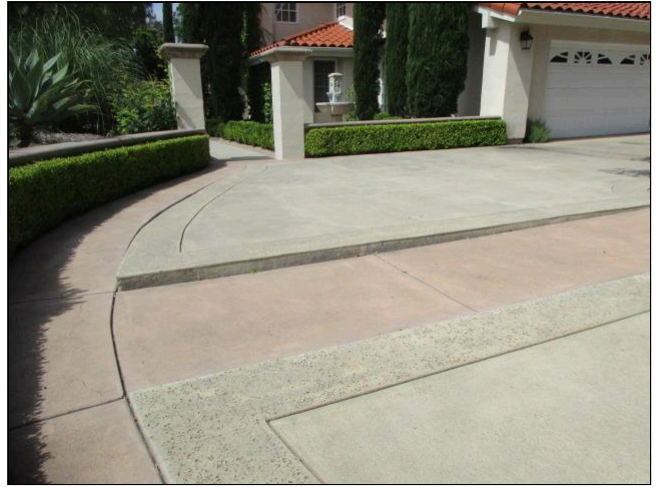
Heaved Drive

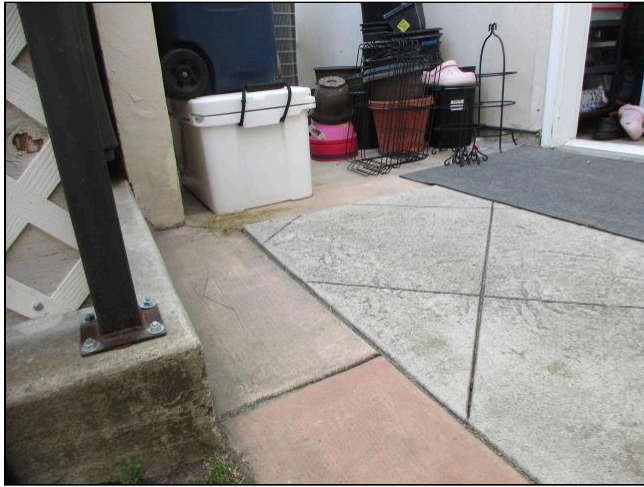
Heaved Walk, Rear

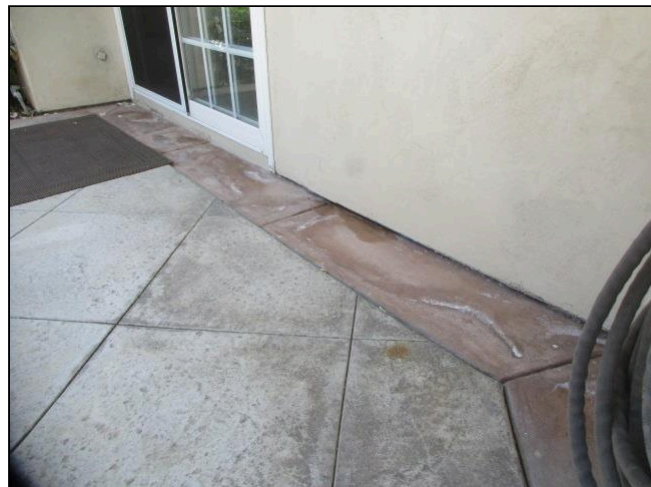
The concrete patio surface is incorrectly sloped at the left side of the home. This will allow standing water and if not corrected water intrusion and/or damage may occur. Have a qualified licensed contractor correct the hardscaped surface and/or extend the in-ground drainage system so that water can be properly controlled and drained away from the home.

Patio Sloped Toward Home, Poor Drainage

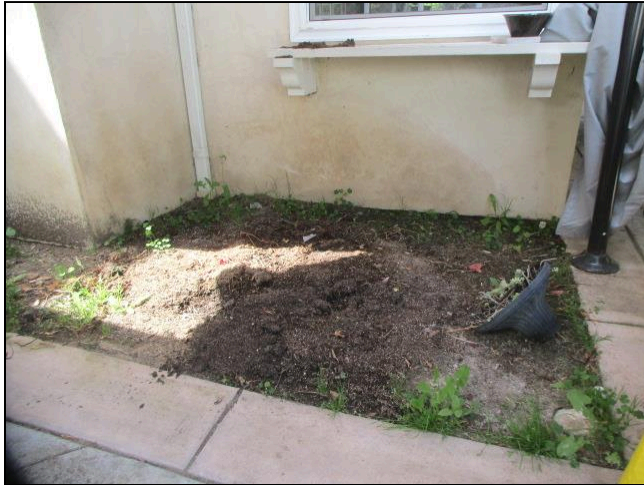
Landscape soils are too high against the exterior stucco siding at the left and rear sides of the home. This can allow water intrusion and damage to the walls if not corrected. Lower the soil levels in the flower beds, 6"-8" below the stucco weep screed is preferable.

Soils Too High, Rear

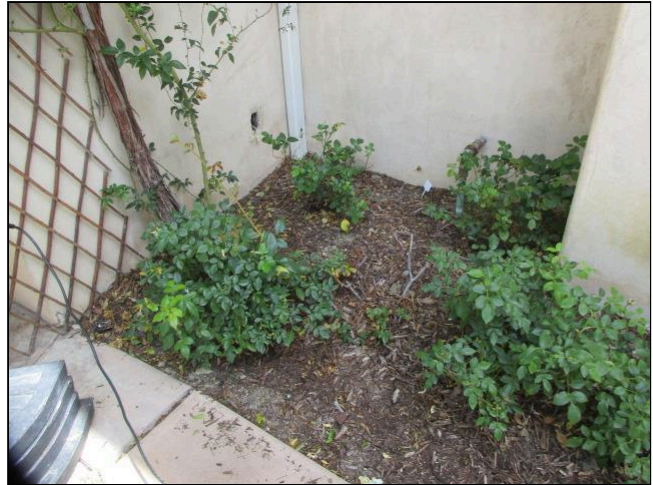
Soils Too High, Left Side

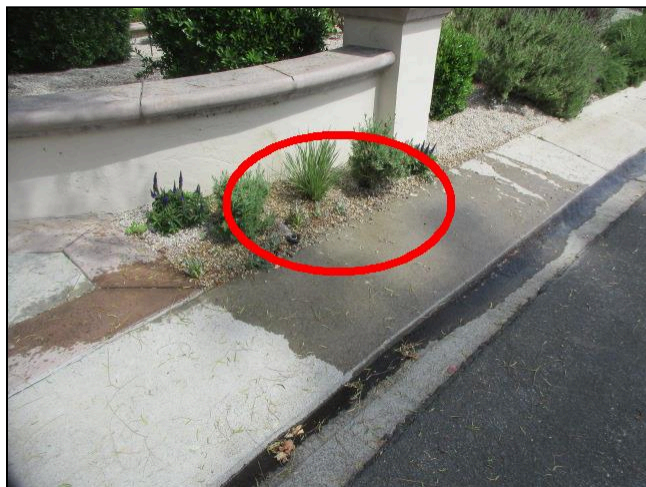
Leaking from underground sprinkler piping was observed during operation at the Rocking Horse street flower bed and active leaking from a sprinkler valve was observed against and into the garage. Water intrusion can damage surrounding materials if not repaired. Have a qualified landscape contractor repair as needed.

Leaking Sprinkler Piping

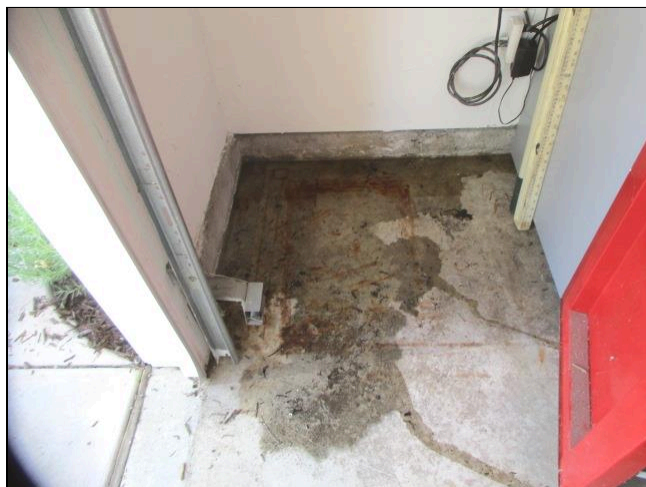
Leaking Into Garage

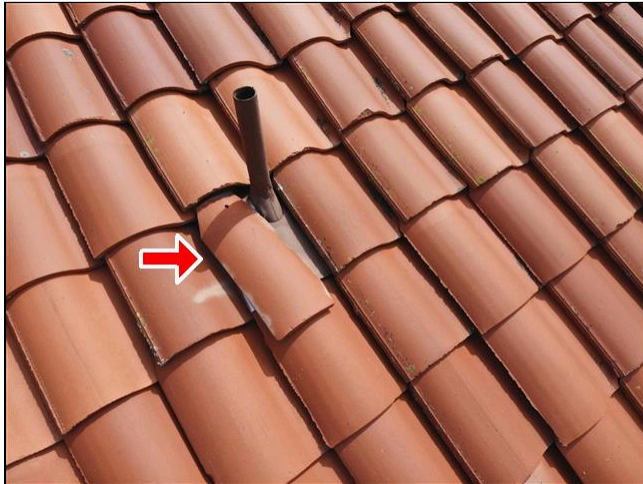
Several broken tiles at the right side of the roof and a loose/displaced tile at the left side of the

roof and staining on the plywood sheathing was observed at the center of the attic, under the left side of the roof. Have a qualified licensed roofing contractor evaluate and repair as needed.

Loose Tile, Left Side

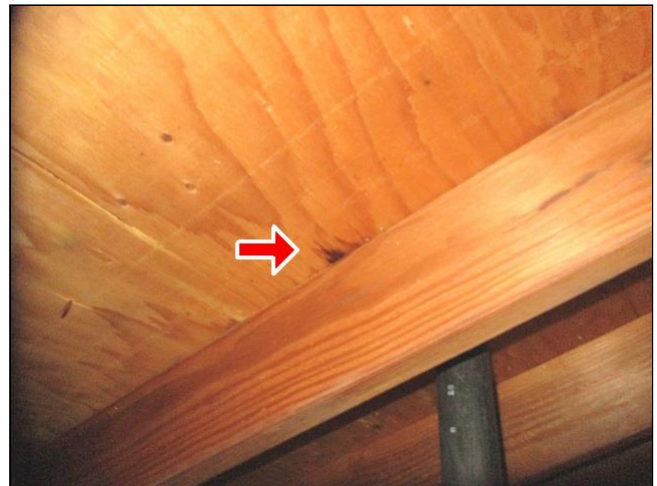
Stained Plywood

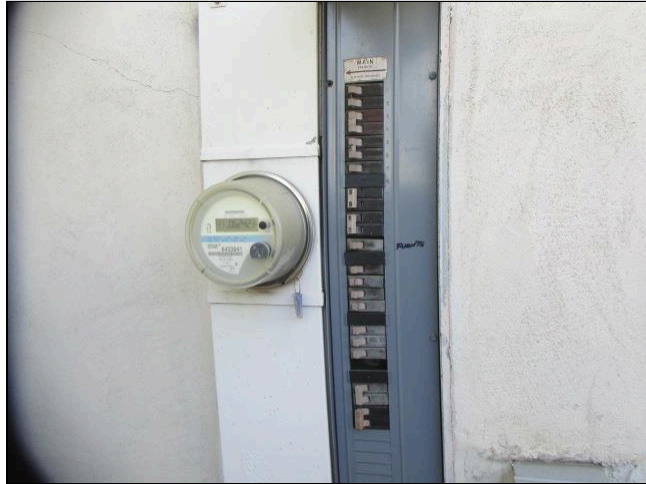
The main electrical panel and pool/spa sub electrical panel are not labeled. This is required by today's standards. Repair as needed.

Labeling Missing

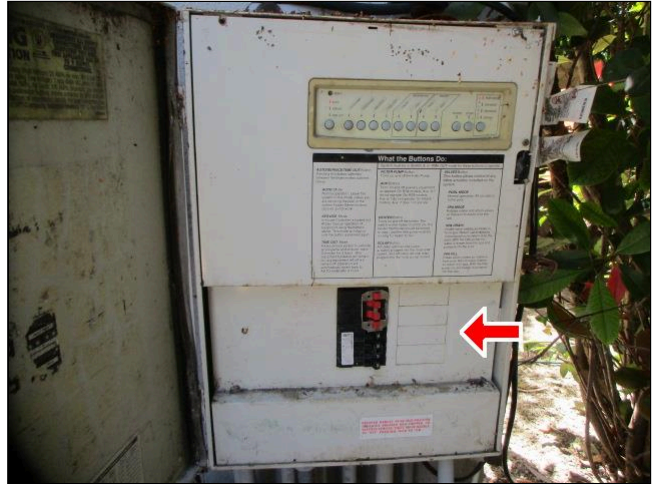
Labeling Missing

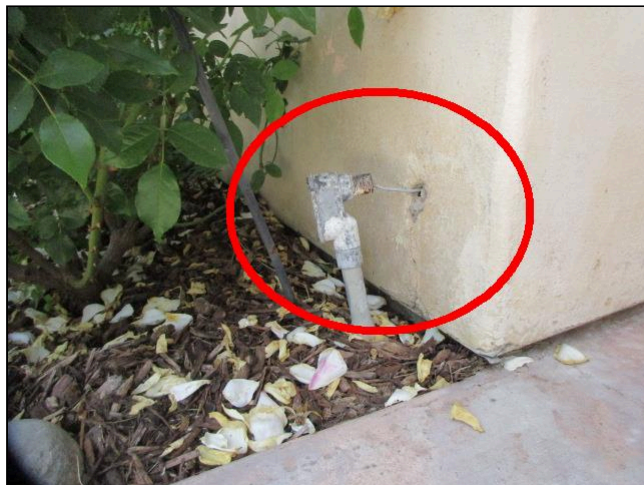
Loose conduit and exposed wiring was observed in the flower bed outside the kitchen sliding glass door. Have a qualified licensed electrician repair or remove for safety as needed.

Loose Conduit, Exposed Wiring

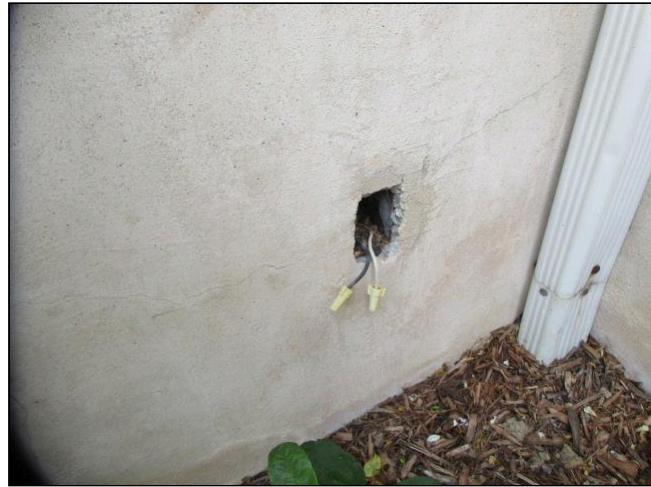
An open electrical junction box or missing outlet exists at the left side of the home, outside the living room. This exposes wiring to contact and is a shock hazard. Have a qualified licensed electrician repair for safety.

Exposed Wiring At Open Box
