Inspection Report

Property Address:
27011 Rocking Horse Ln
Laguna Hills CA 92653

Date: 6/24/2023	Time: 10:00 AM	Report ID: 27011Horse
Property: 27011 Rocking Horse Ln Laguna Hills CA 92653	Customer: REvesty LLC	Real Estate Professional: Niko Trimino

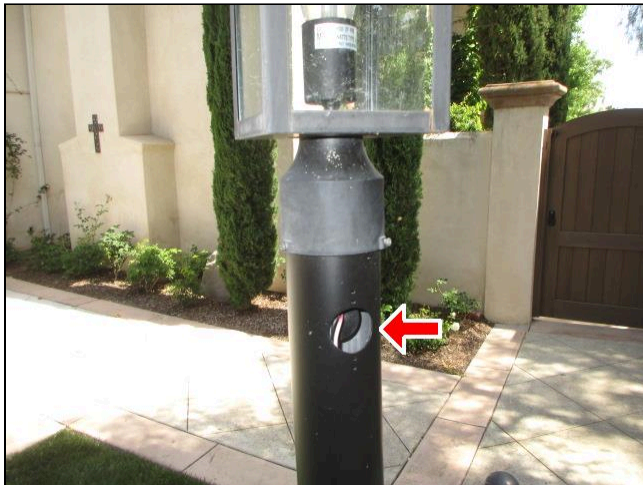
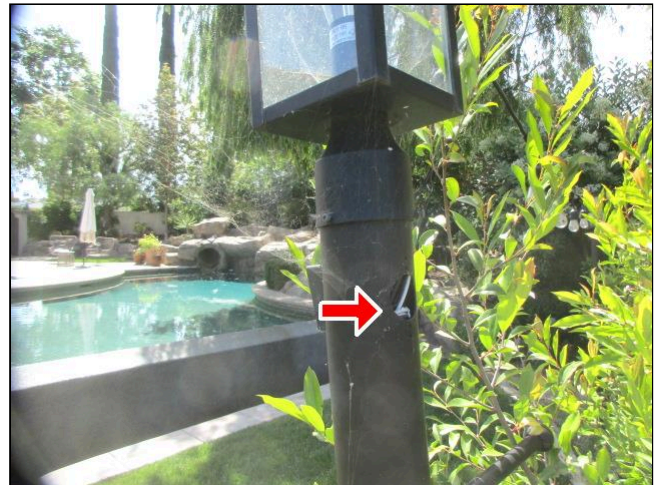
Exposed electrical wiring is present at several of the post lights where cover plates are missing, around the pool/spa area. Have a qualified licensed electrician repair for safety.

Exposed Wiring

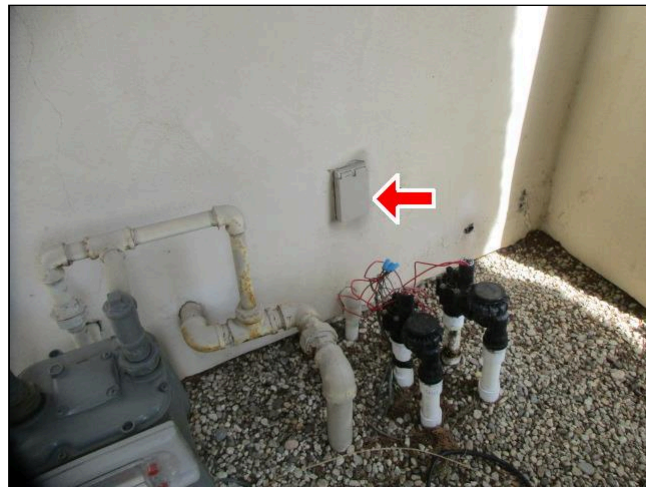
A GFCI (Ground Fault Circuit Interrupter) outlet at the front (left garage exterior) did not trip when tested (defective). This is a safety issue that needs to be corrected by a qualified licensed electrical contractor.

GFCI Fails To Trip

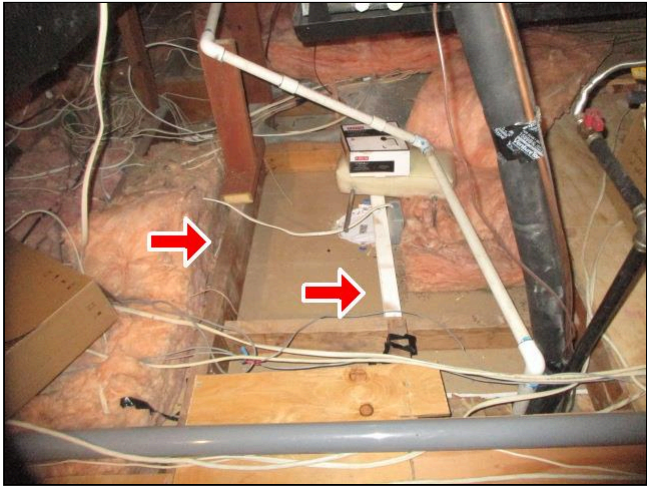
Ceiling joists have been cut and altered in the attic, adjacent the pull down ladder, without proper reinforcement. Have a qualified licensed contractor evaluate and repair as needed.

Ceiling Joists Cut, Not Reinforced Properly

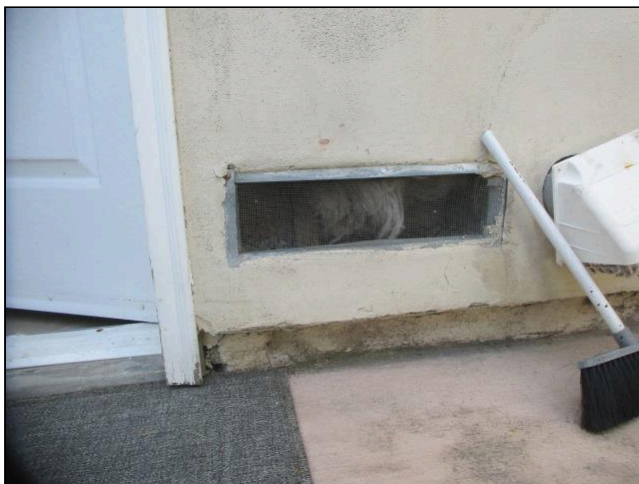
Wall vents are blocked/covered at the right side of the garage. Open the vents to allow for proper air circulation into the garage.

Garage Vents Blocked/Covered

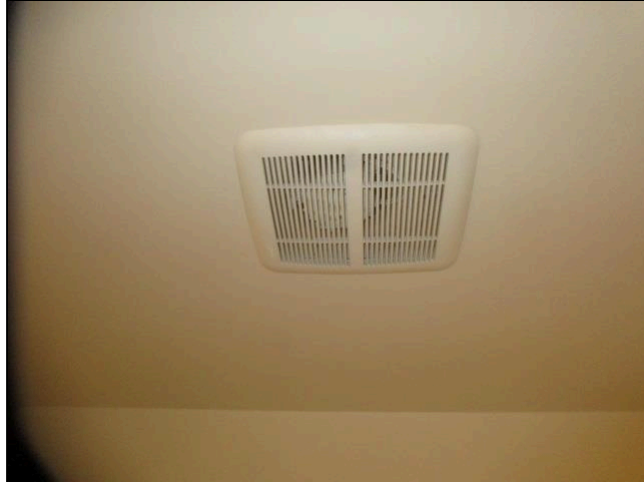
The exhaust fan did not work in the downstairs guest bath. Have a qualified licensed contractor repair or replace for proper ventilation as needed.

Fan Not Operational

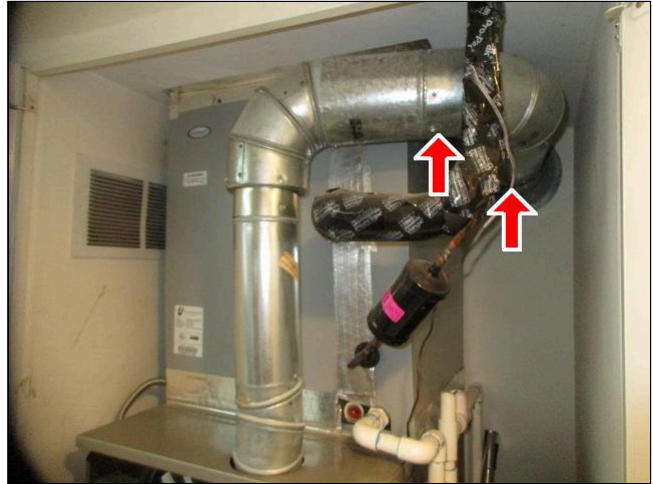
Vent Slope Improper, Downstairs Furnace

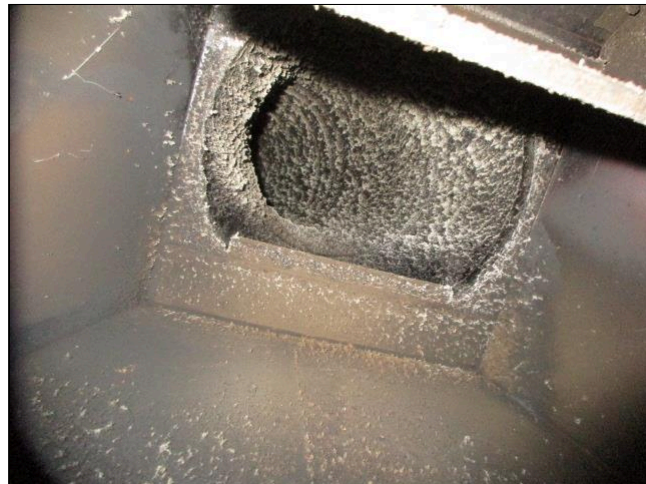
A build-up of creosote is present in the primary bedroom fireplace at the damper, smoke chamber & chimney. Contact a qualified chimney sweep service to clean the fireplace and chimney for safe use.

Creosote, Primary Bedroom

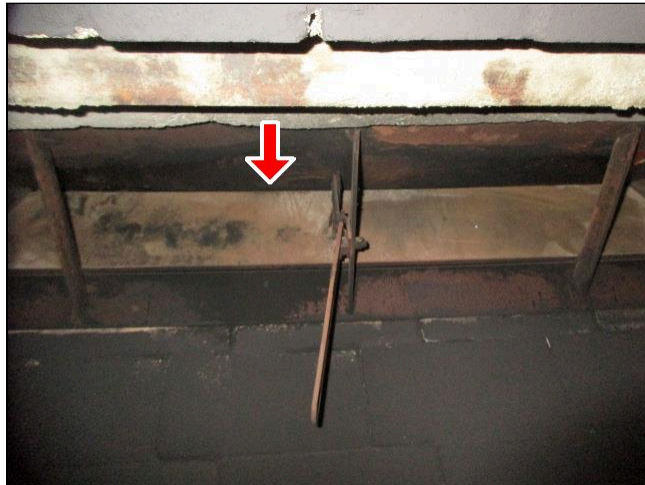
The damper for the living room and family room fireplaces is missing a clamp or lock that forces the lid to stay open. Without a clamp to force open the damper, it could allow unsafe carbon monoxide to enter the home. Install for safety.

Add Damper Lock, Living Room

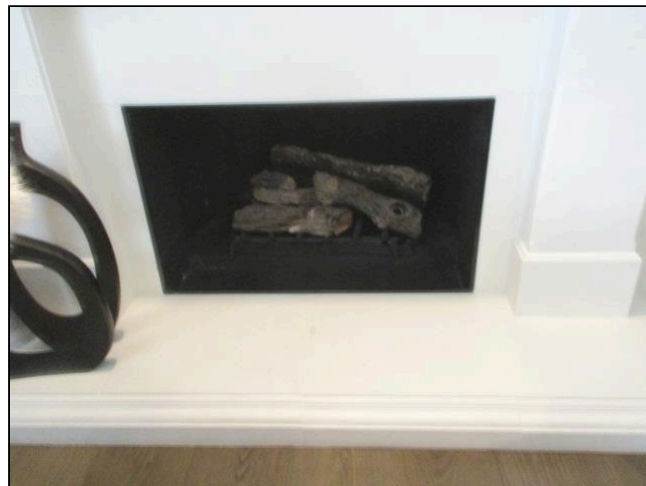
Doors or screens are missing at the opening of the living room fireplace. This is necessary to help prevent embers from escaping the firebox during use. Install doors or screens as necessary.

Add Doors/Screens

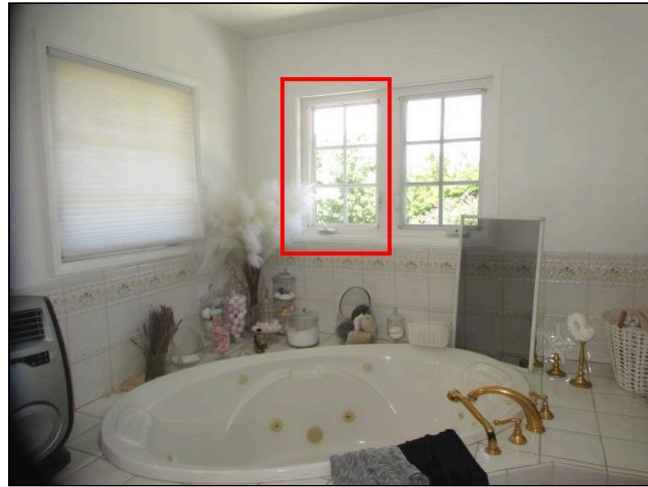
A window over the primary bath tub is not tempered safety glass. This is a slip & fall injury hazard; glass around a tub/shower will break into large shards when broken if it is not tempered glass. Have a qualified licensed window contractor repair for safety.

Glass Not Tempered

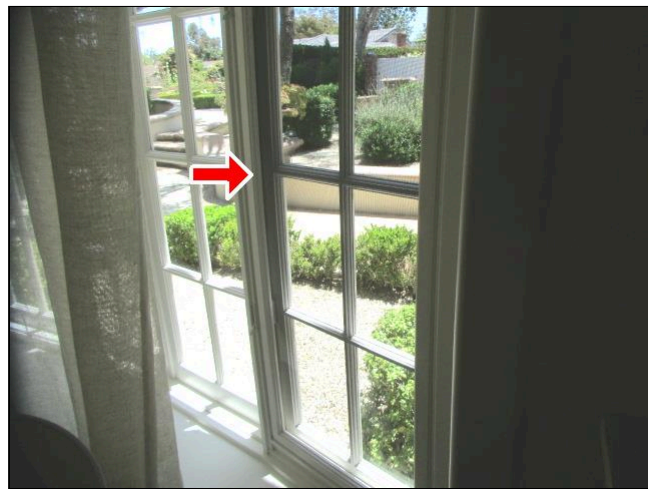
Two wood casement windows bind in the frames and do not open at the living room bay windows. Have a qualified licensed window contractor repair as needed.

Windows Bind, Do Not Open

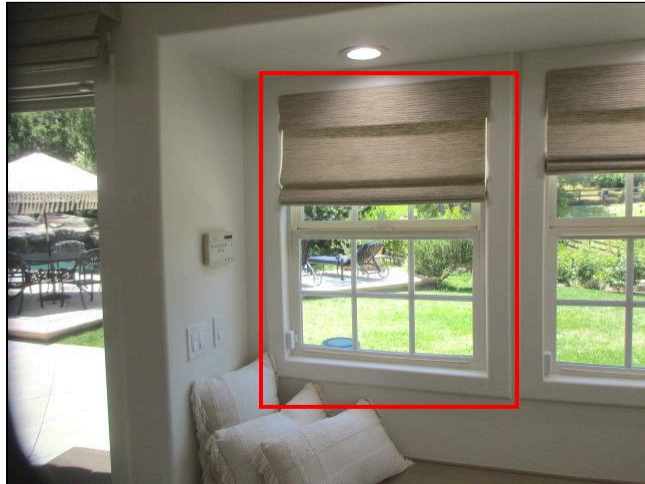
A single hung window has a broken lock handle at the left wall of the breakfast nook. Have a qualified licensed window contractor repair for proper operation as needed.

Broken Lock

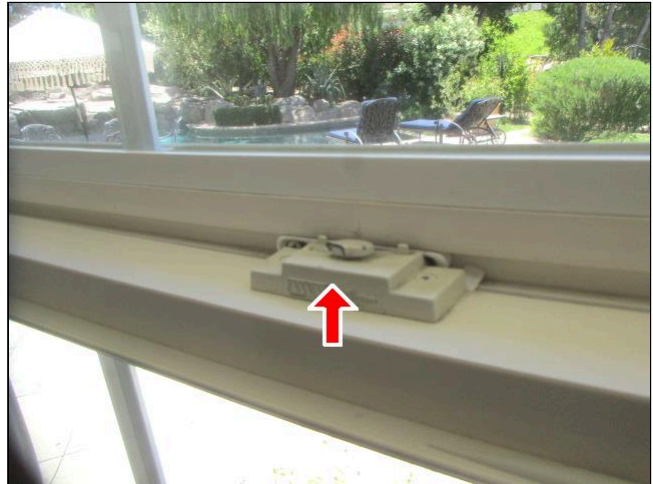
Broken Lock

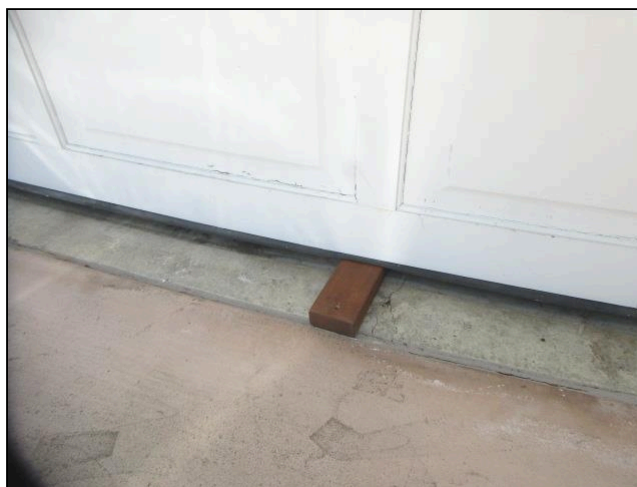
The automatic opener for the double car garage vehicle door will not reverse when met with resistance. This is considered unsafe and needs correcting by a qualified licensed garage door contractor.

Door Does Not Reverse

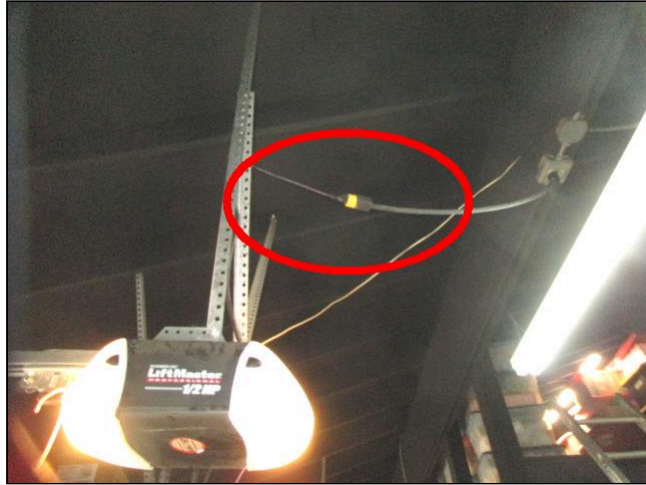
The automatic openers for the single car and double car garage doors are using an extension cord as permanent wiring and should have its own dedicated outlet. This is considered unsafe and needs correcting by a qualified licensed electrician.

Extension Cords In Use

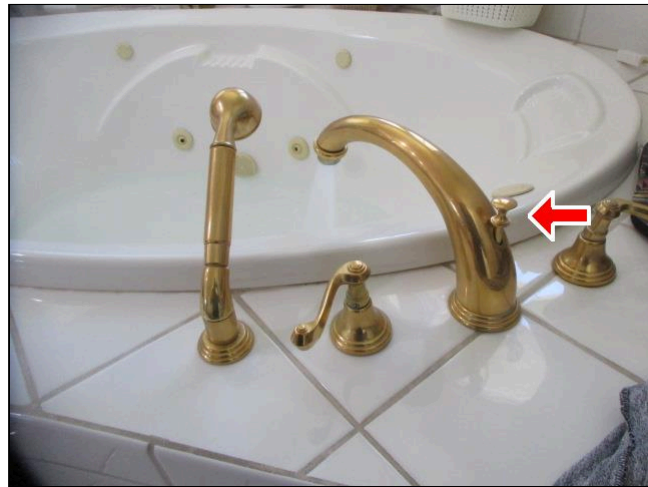
The tub spout/wand diverter does not operate at the primary bathroom. A qualified licensed plumber should repair as needed.

Diverter Not Operational

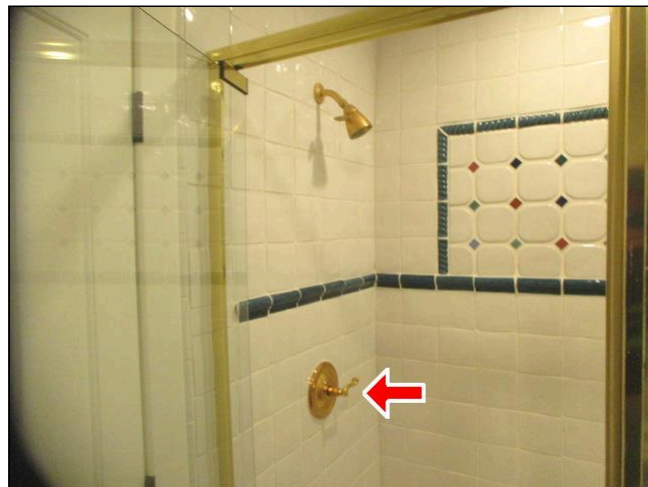
The shower faucet does not operate in the downstairs guest bath. A qualified licensed plumber should repair as needed.

Shower Faucet Not Operational

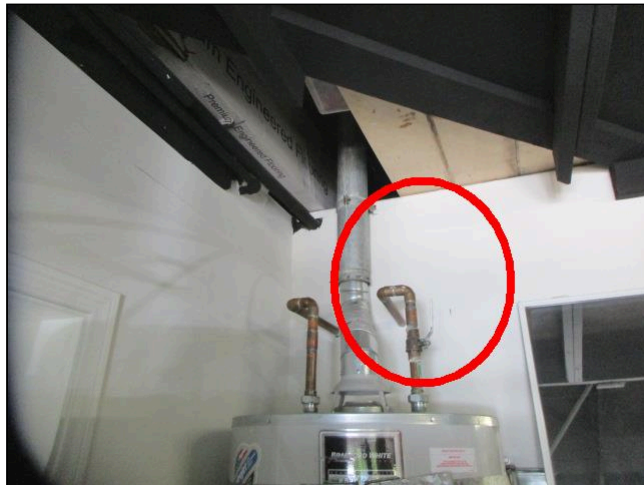
The water heater is missing a thermal expansion tank on the cold water supply. These are typically required when the water heater is replaced and a closed plumbing system exists. A qualified licensed plumber should repair as needed.

Thermal Expansion Tank Missing

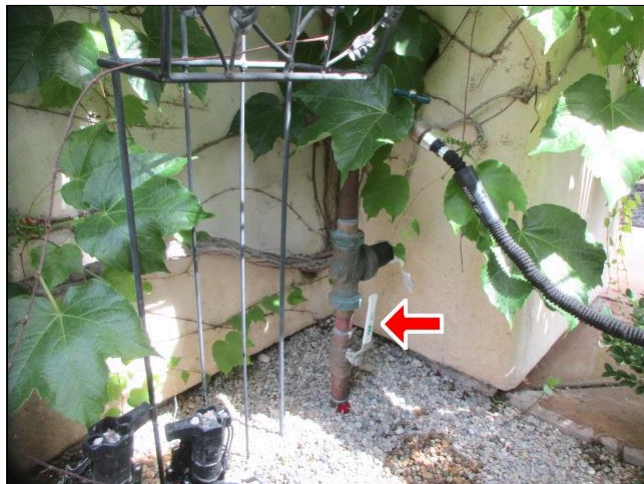
The main water shut off is the white lever located at the front exterior.

Main Water Shut Off Valve

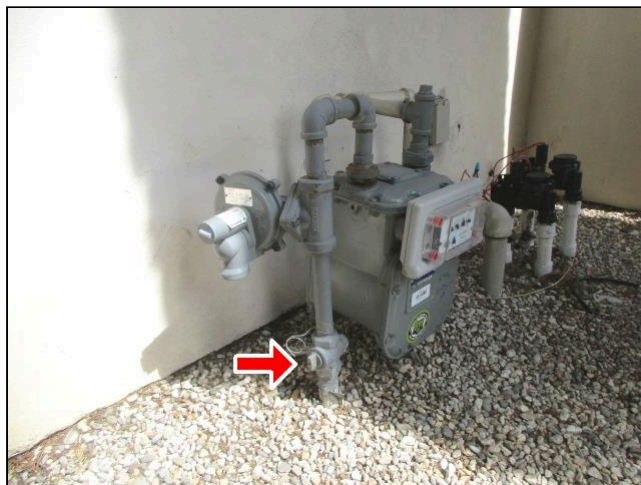
The main gas shut off is located at the gas meter at the front exterior.

Gas Shut Off Valve

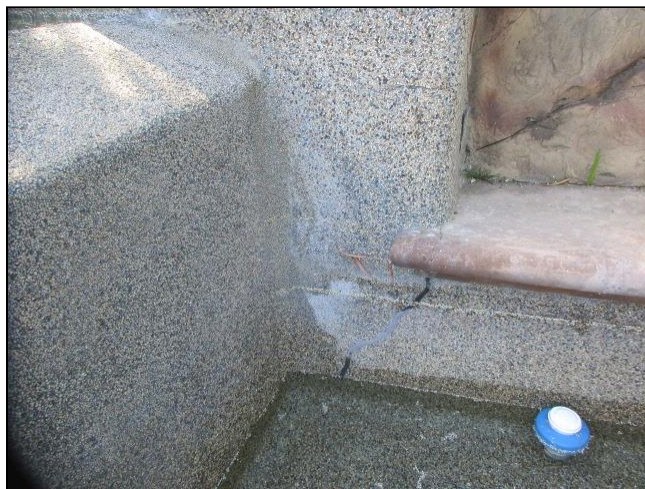
Note: Previous repairs at the pool steps and collection areas were observed. Inquire with the seller for past problems, repairs performed, contractor warranty/guarantee and additional information.

Previous Reparis, Collection Area

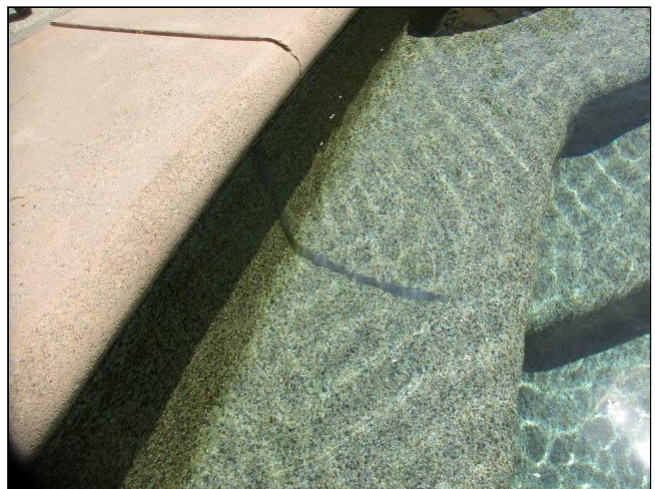
Previous Repairs, Pool Steps

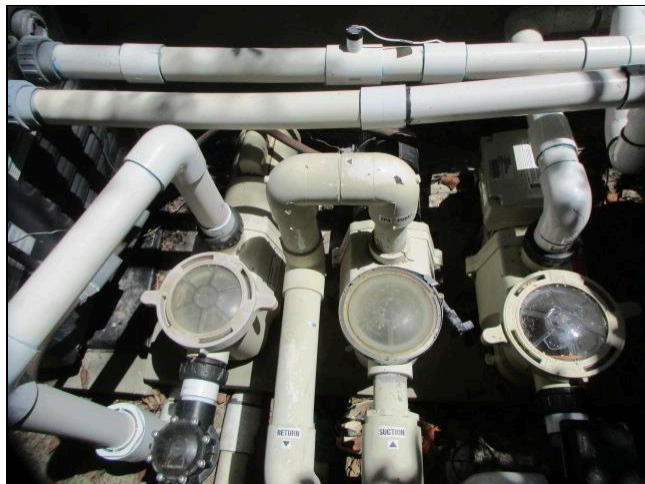
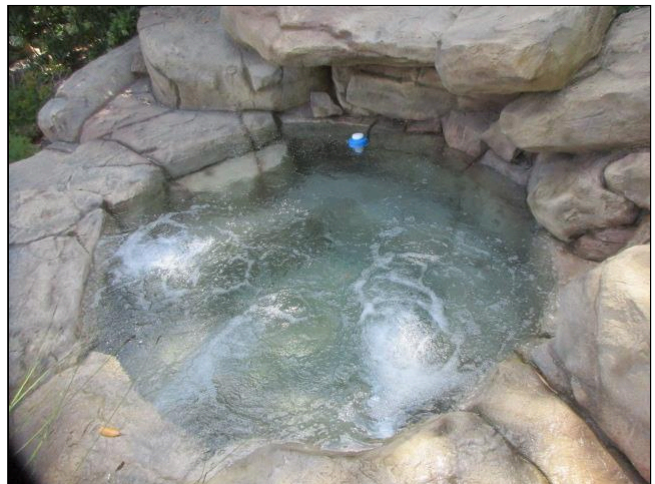
The spa booster pump did not operate properly when tested with manual controls. Have a qualified licensed pool contractor review and repair or replace to ensure proper operation.

Spa Booster Pump Not Operating Properly

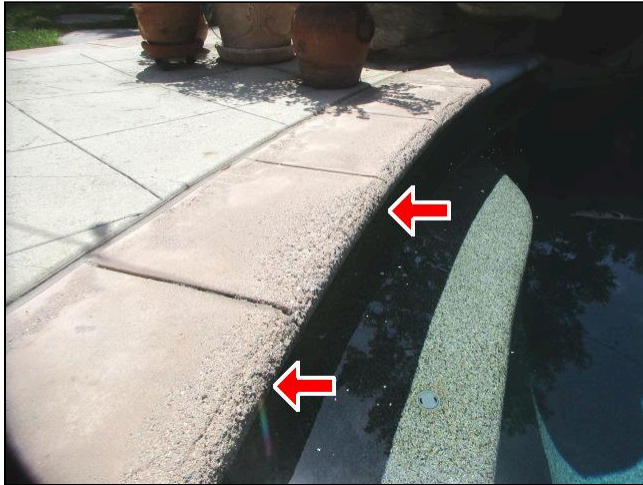
Damage to the pool coping and sidewalls of the collection area were observed. Have a qualified licensed pool contractor repair as needed.

Damaged Coping

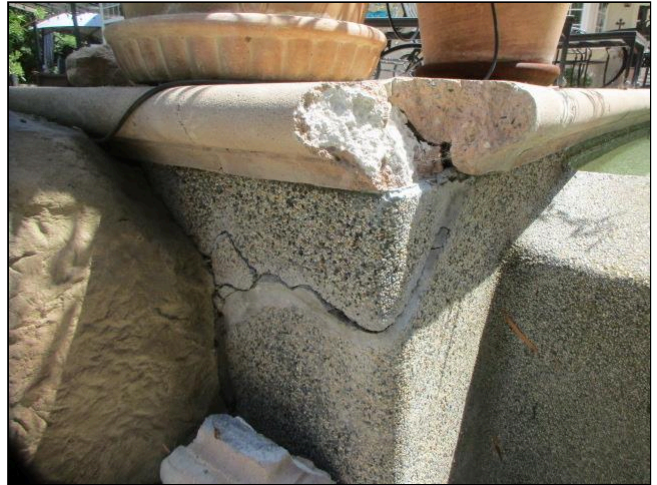
Damaged Coping, Sidewall

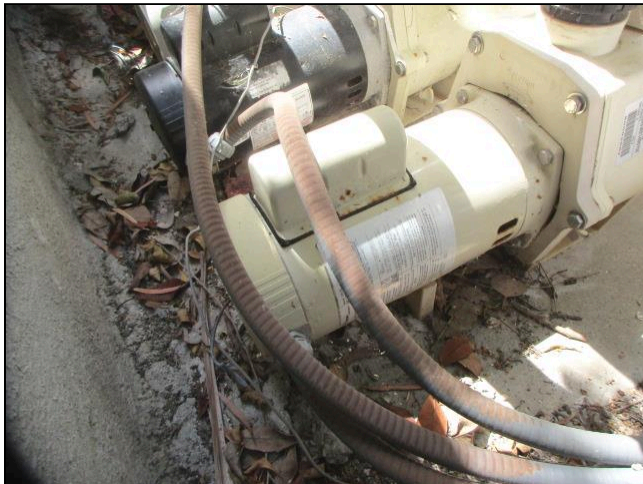
The circulation, waterfall and spa booster pumps are not properly bonded to ground. This is a safety feature that should be repaired by a qualified licensed pool contractor in case of an electrical fault.

Pumps Not Bonded To Ground

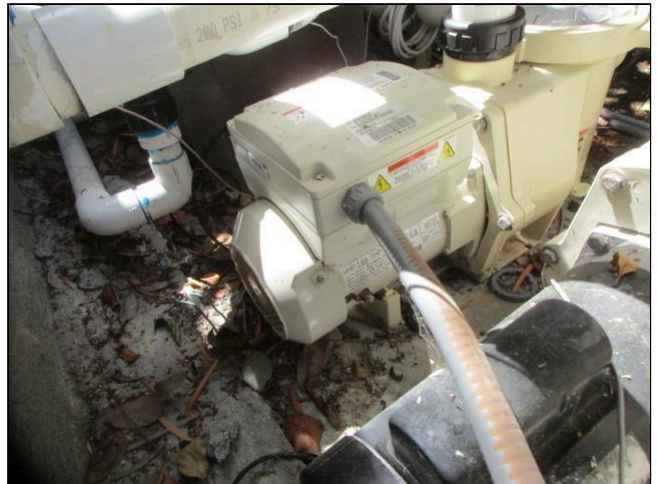
Pumps Not Bonded To Ground

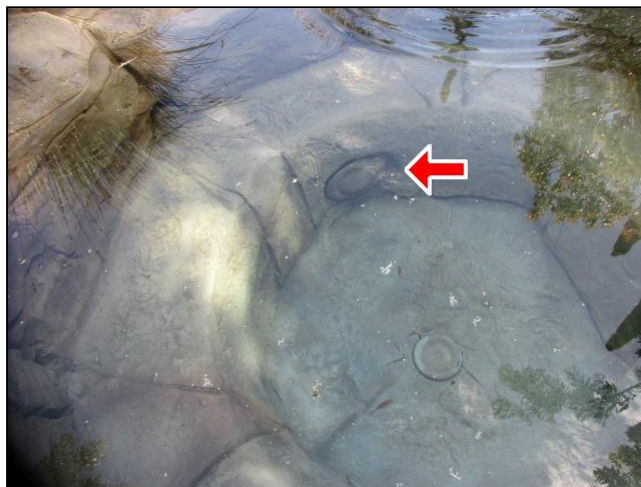
The spa light was not operational at the time of inspection. Have a qualified licensed pool contractor repair as needed.

Spa Light Not Operational

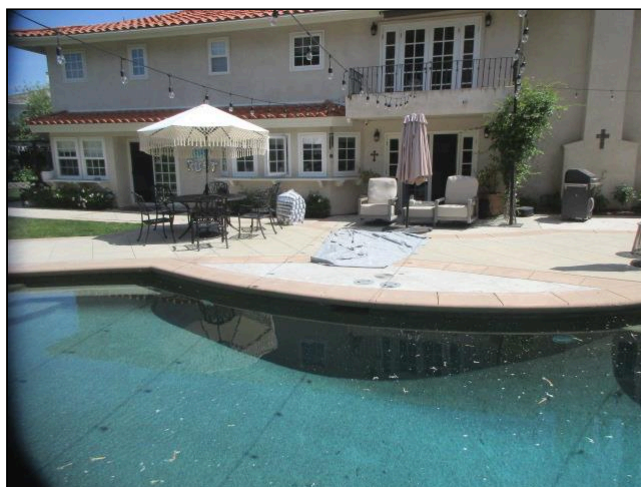
The exterior doors allow direct access from the house and garage to the pool/spa area. This is a significant safety and childproofing issue. I recommend you have a qualified licensed pool contractor properly install an enclosure, fencing, cover, door alarms, water surface alarm and/or childproof locks as necessary.

Direct Access To Pool/Spa

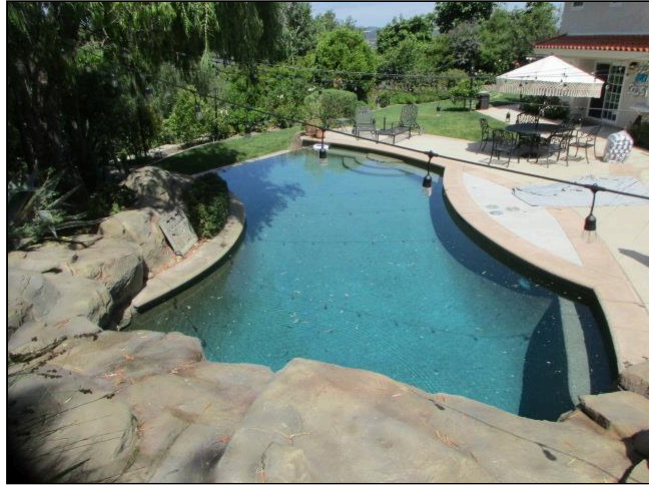
Less Than (2) Drowning Prevention Features Present
